Geotechnical Completion Report

HITCHEN BLOCK STAGE 13A

DFH JOINT VENTURE LIMITED

16 August 2021

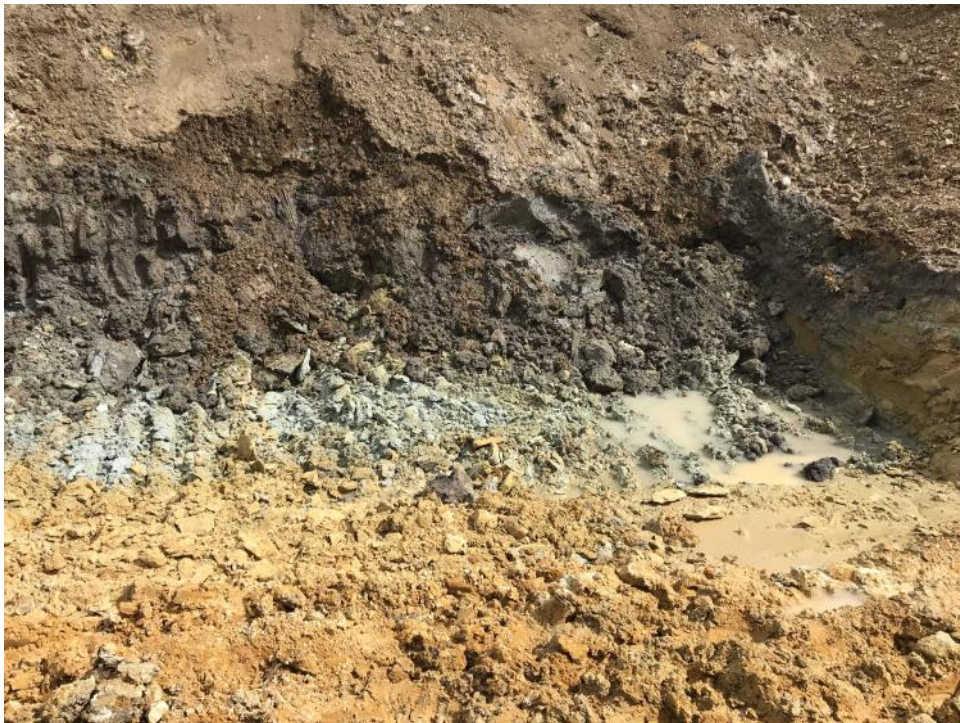
Sides of batter are also sub-vertical. Recommended these be battered to a safe angle to provide a safe working area below.

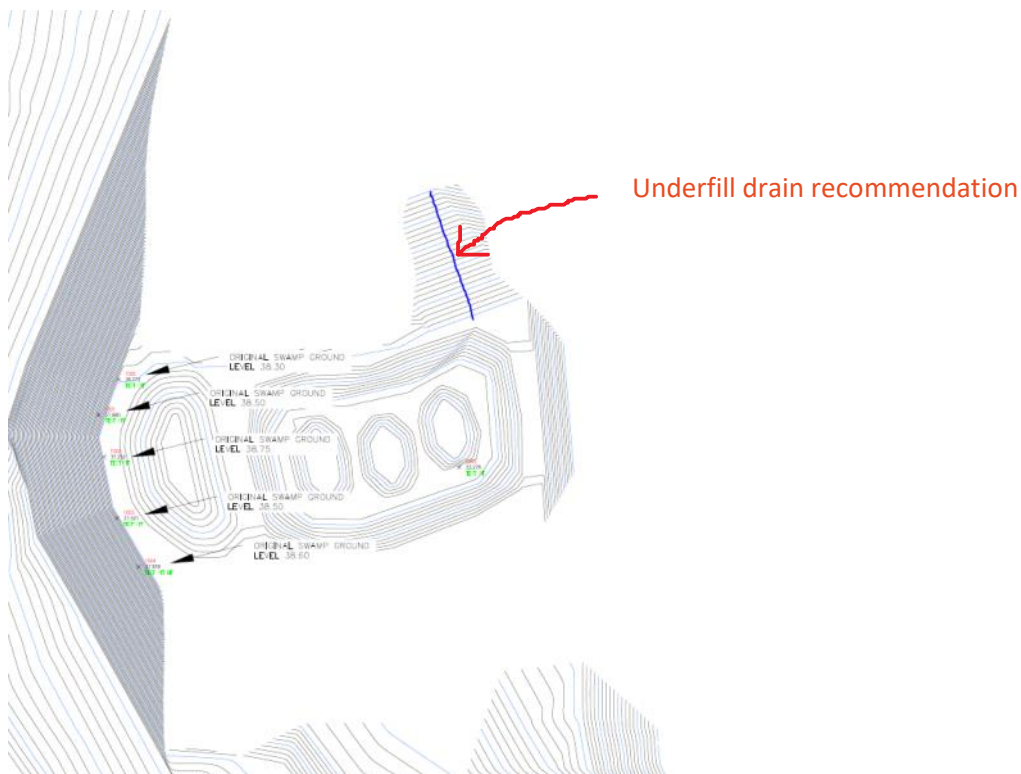
Observed Cut 4 pond. This area has been filled with clear and is now near pond base invert level. While down here discussed a proposed fill batter which we recommended has an underfill drain installed to tap any groundwater pressures (area shown on the plan below).

Contractors also removing fill from an old rubbish pit found on site at the start of the season.

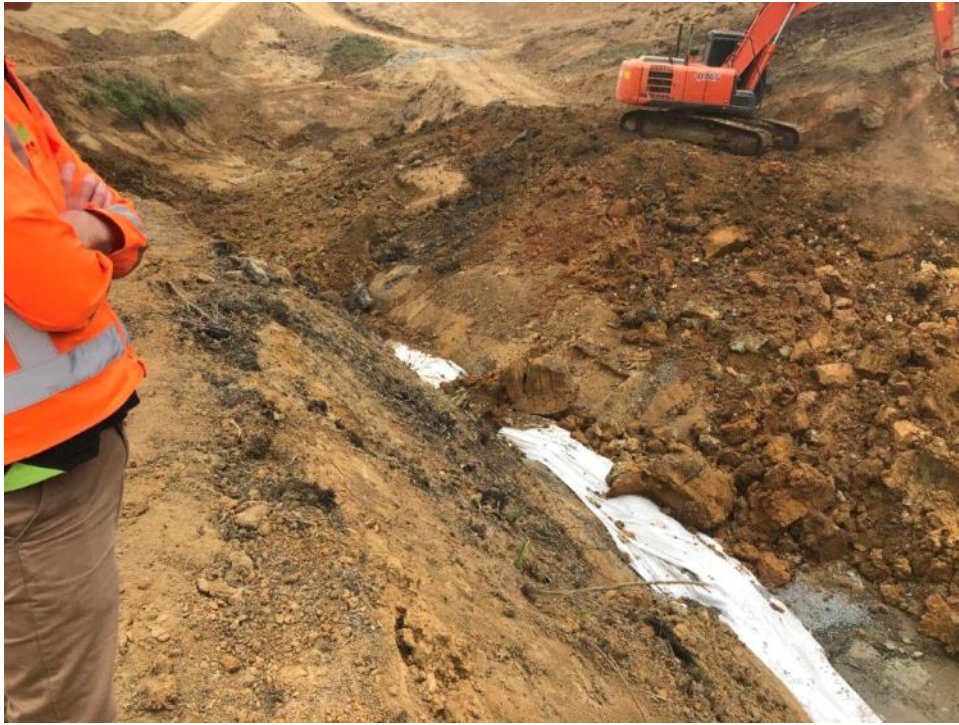
Underfill drain has been placed within Fill A gully observed during previous inspection.

Elsewhere, the site is mostly in the same condition as our previous inspections.

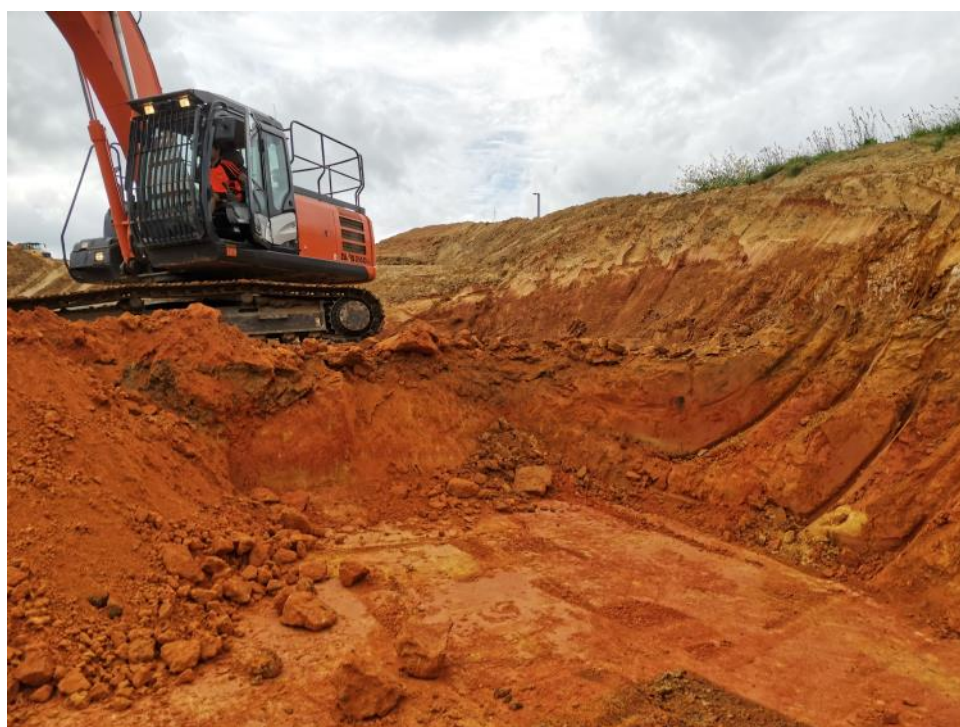
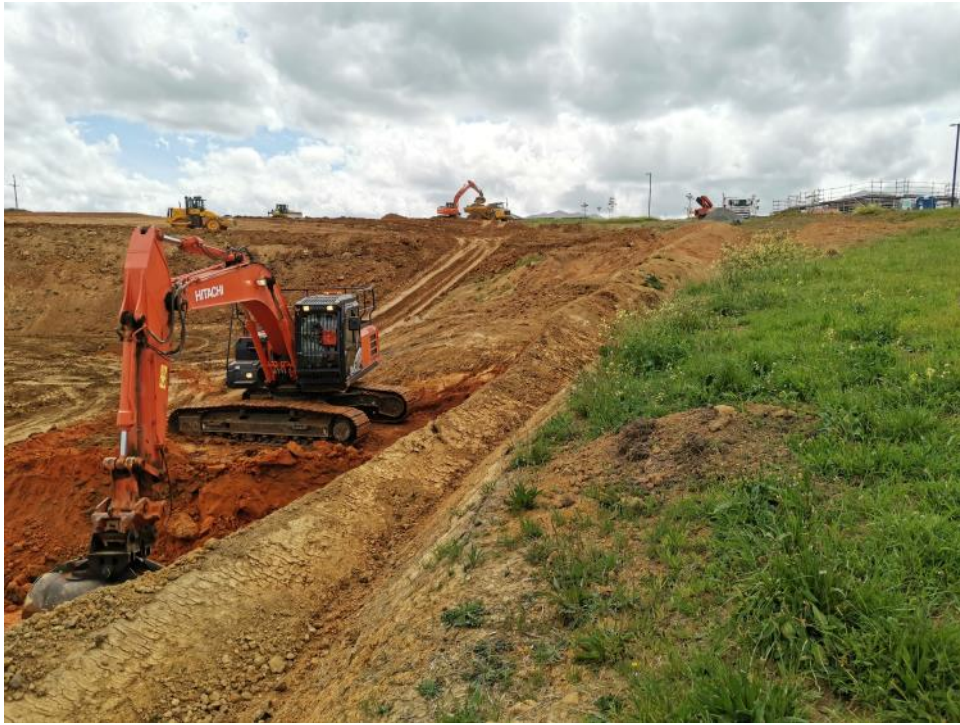
- Visited Kitchin 120 to inspect earthworks operations. Fill placement is in progress and they are planning on opening up the remainder of the gully once they have a spell of fine weather.
- REB1 earthworks are still in progress. At the time of inspection the contractors were preparing their benches ready for the placement of the next layer of fill, which is likely to be tomorrow morning.
- Silt pond excavations are still underway at the far end of site (relict ship area)

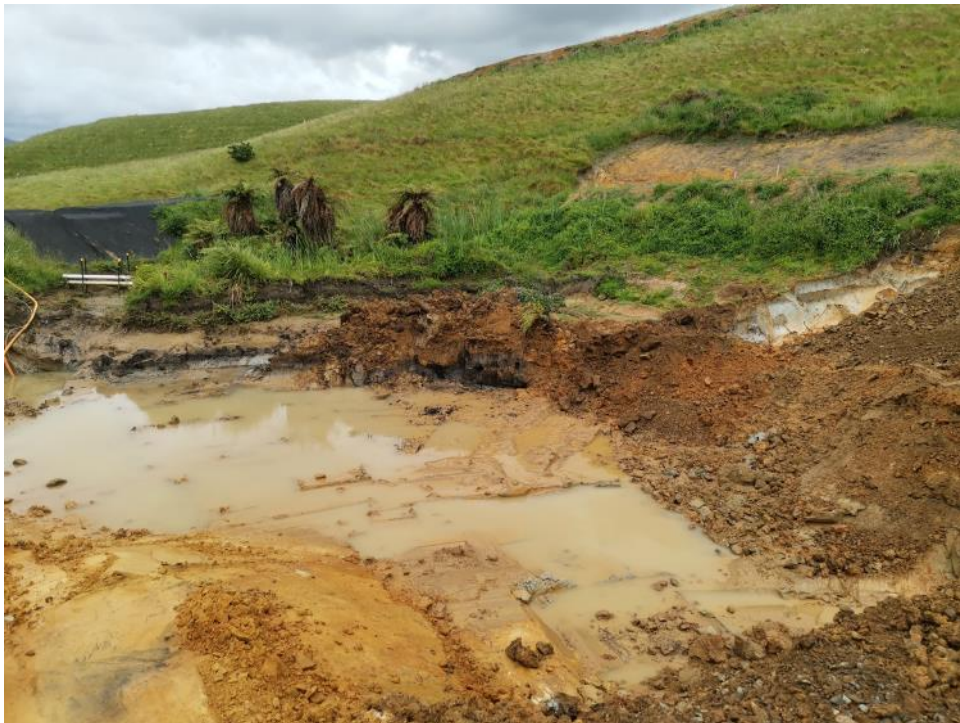
Visited site at the request of Dylan to inspect the undercut for the shear key in REB2. The contractors had cut down approx 4m from original ground level and had excavated down to hard orange silts.

Checked these works against our model which confirmed that the approximate depths and materials were consistent with our model. Informed Dylan that shear key operations could continue as planned, but 2 or 3 trial pits will be required in the base of the shear key once it has been opened up to further validate the ground conditions beneath the base of the shear key.

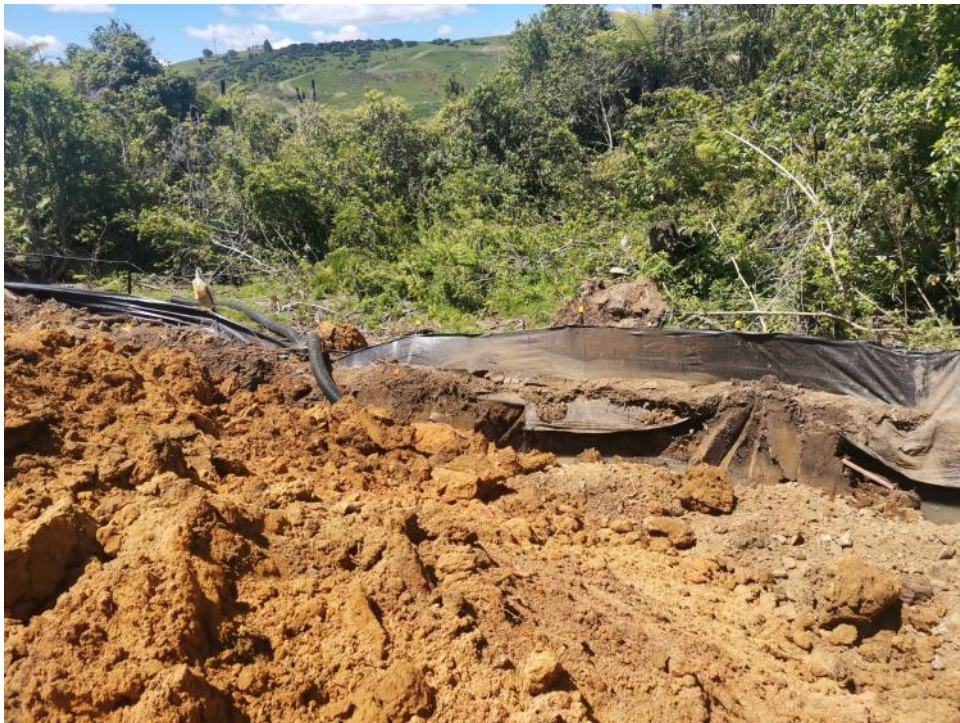
Not much progress has been made since our last inspection in this area. The SPR in the base of the gully is still loose and requires compaction. The contractor is planning to bring a pad-foot roller down to this area to start backfilling the gully.

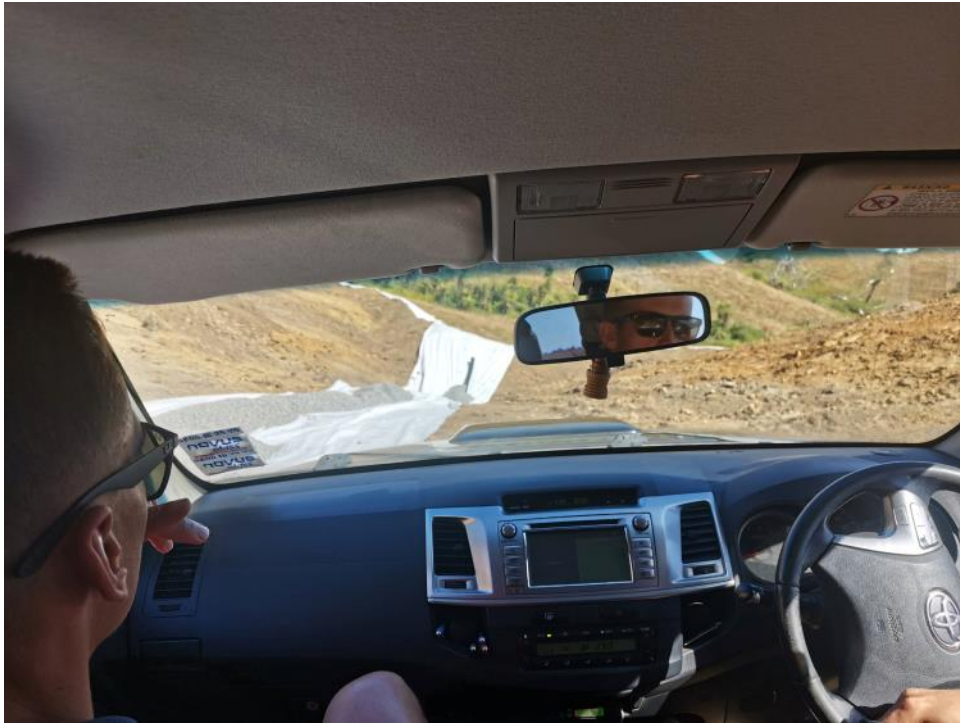
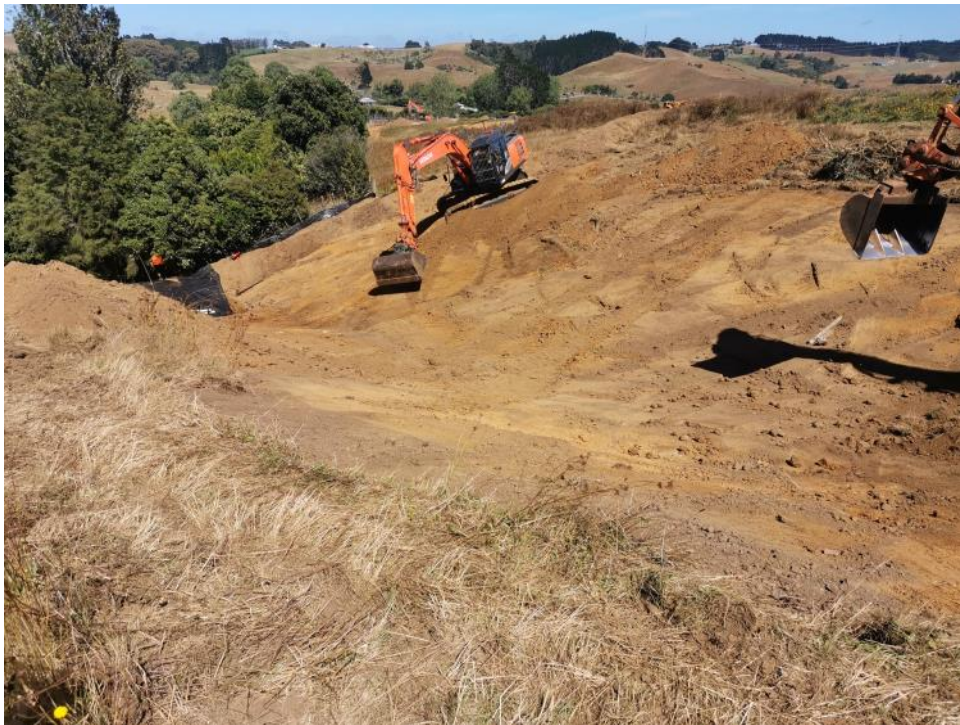
- Observed muckout of organic and soft alluvium materials below the underfill drainage line upslope of the REB2 shear key. The contractor had excavated down to the hard materials exposed at the base of the shear key. Advised him that this could be reduced to the base of any major organic layers, provided that the inorganic soils are competent enough to place and compact engineered certified fills upon. Will return in a day or two to observe progress.

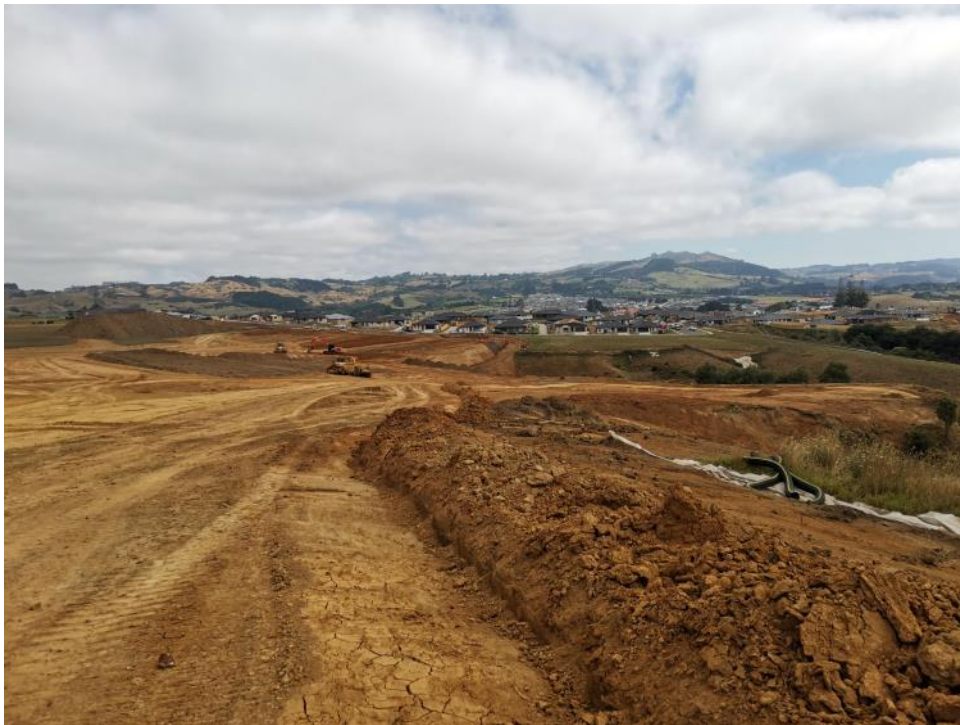
- Within Stage 12D the 1(v) in 3(h) batter has been formed to final height and has been trimmed and topsoiled.
- Stripping has commenced up the flanks of the gully in REB2 for preparation of the fill batter placement. Recommended the installation of 3 additional underfill drains in areas of seepage, two up the eastern flank and one up the southern (rear) which will connect into the existing underfill drain.
- Discussed that benching into the flanks will require an average bench depth of 2m which Dines have already programmed up.
- Will meet on Friday with Cirtex and Chris to discuss topsoiling the face of REB1 as the contractors are having difficulty getting the topsoil to stay in place.

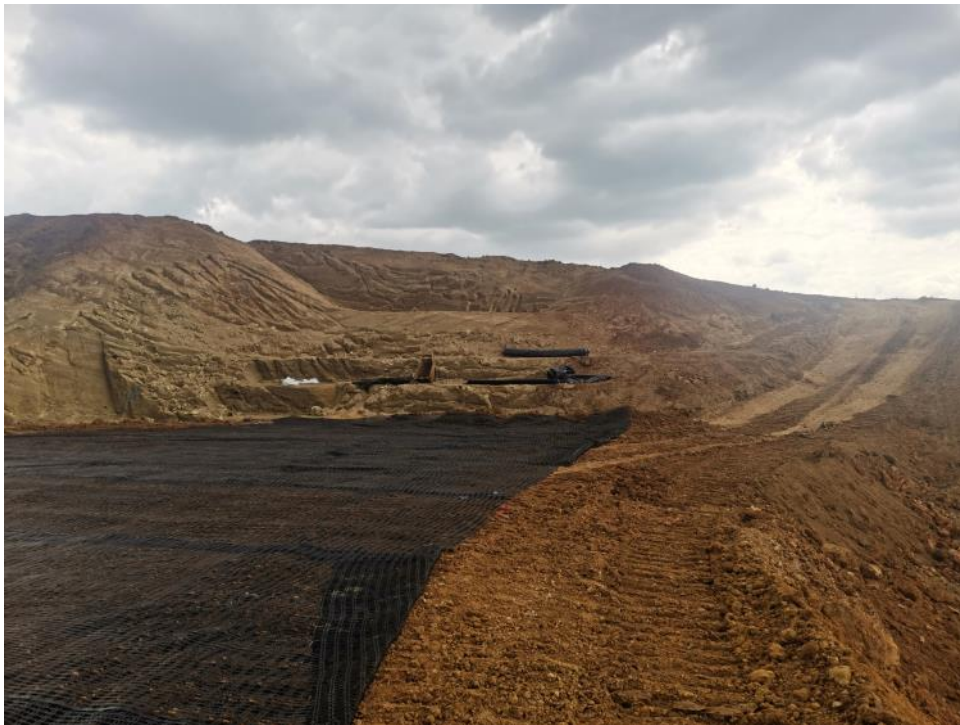
- Observed progress of REB2 batter fill operations.
- Geogrid laid out to approx. 19m length as per our design. A gap remains in the centre section which is to be picked up and covered at the next primary grid lift.
- Fill compaction results have generally been passing, after a series of failed fill tests a few weeks ago (failed on air voids).
- Adequate benching exposed along the gully flanks.
