Geotechnical Completion Report

HITCHEN BLOCK STAGE 13A

DFH JOINT VENTURE LIMITED

16 August 2021

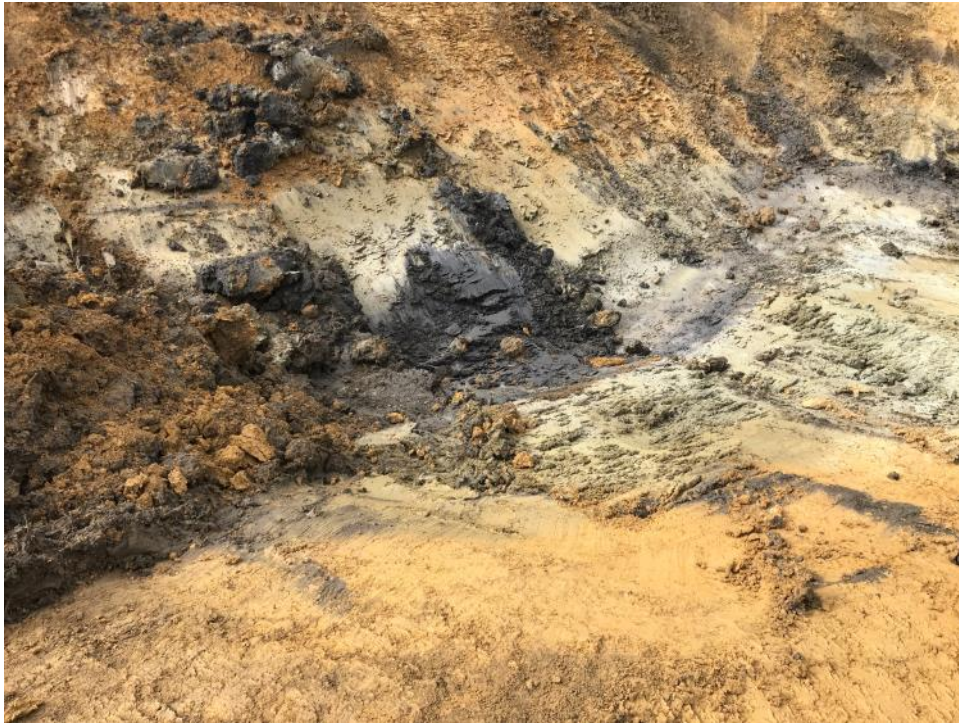
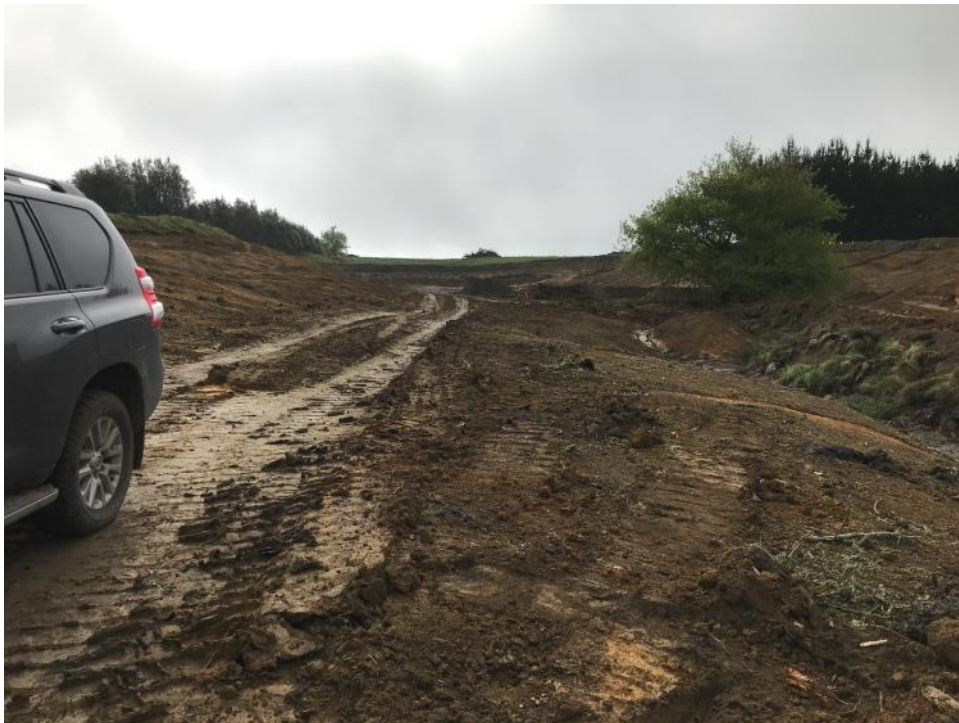
Contractor also to install nominal toe key. Discussed with Trevor that this should be a buckets width wide at base and should extend across the face of the gully. Trevor to send photos once this is complete.

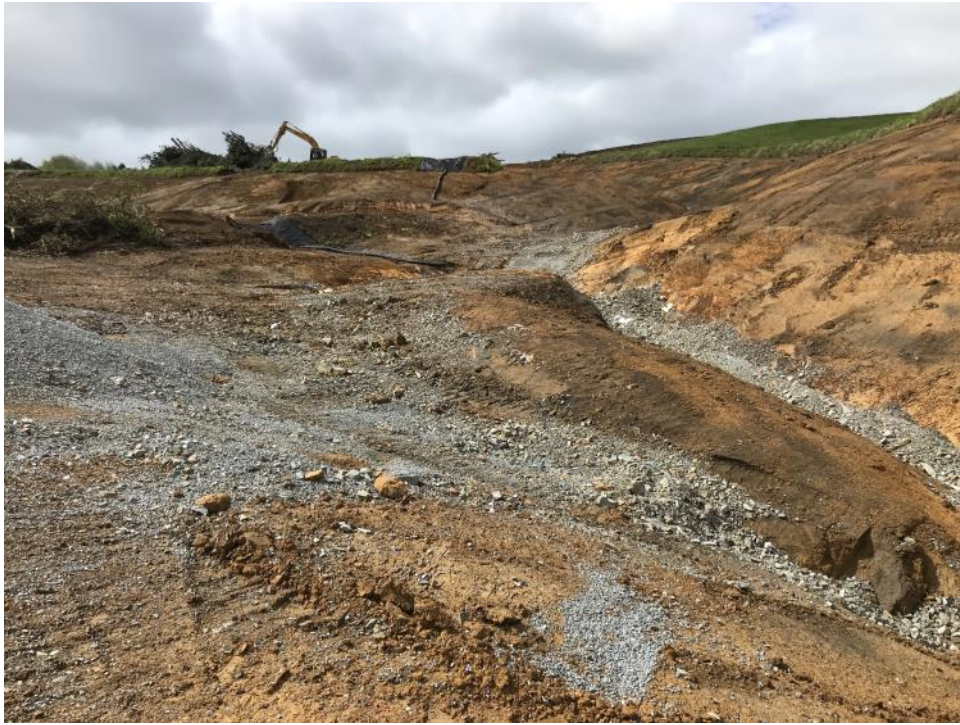
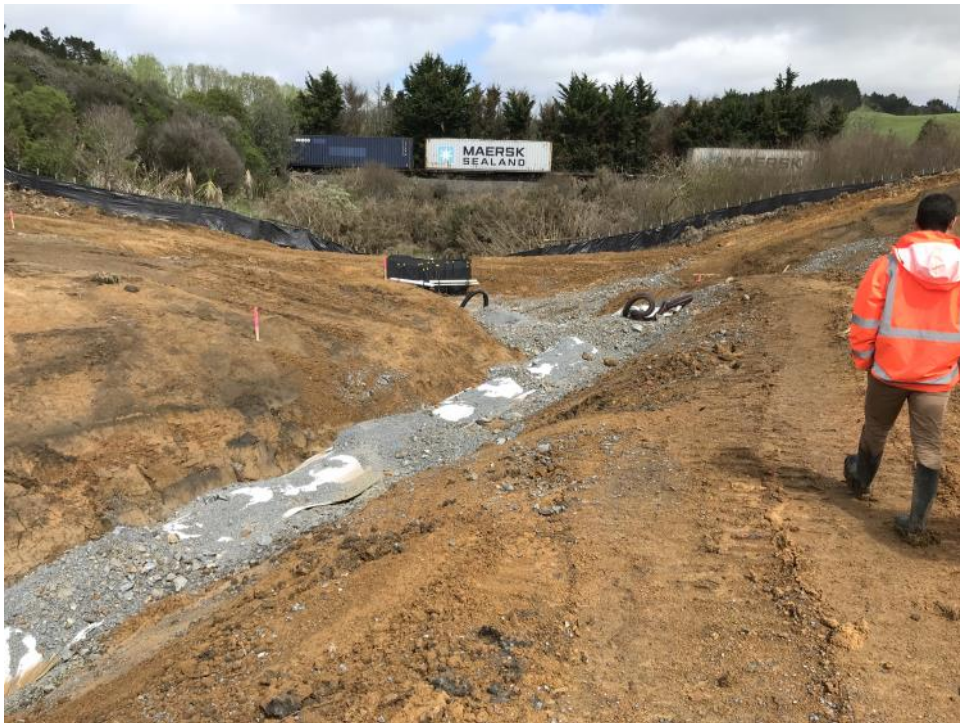
16/10/19 - Fill E/F

Discussed likely outcomes for this season and next at Hitchen Stage 5 and also discussed toe key requirements - these being nominal keys 4-5m wide at base and keyed into the sides of the gullies.

Will return to site tomorrow morning to inspect remediated toe key in fill F which is being widened to meet the 5m width criteria.

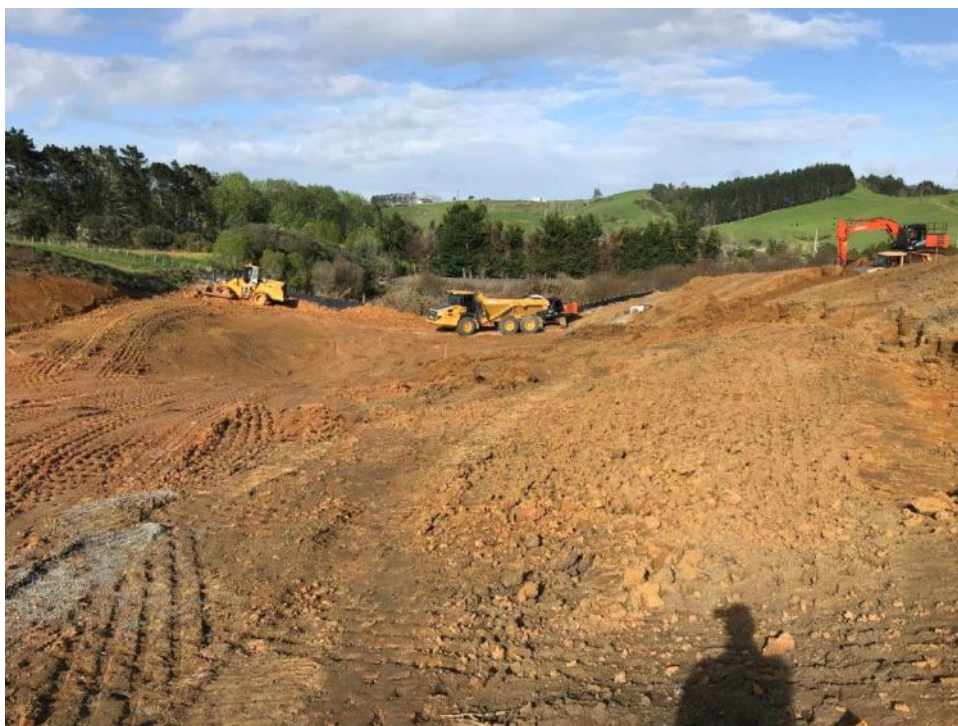
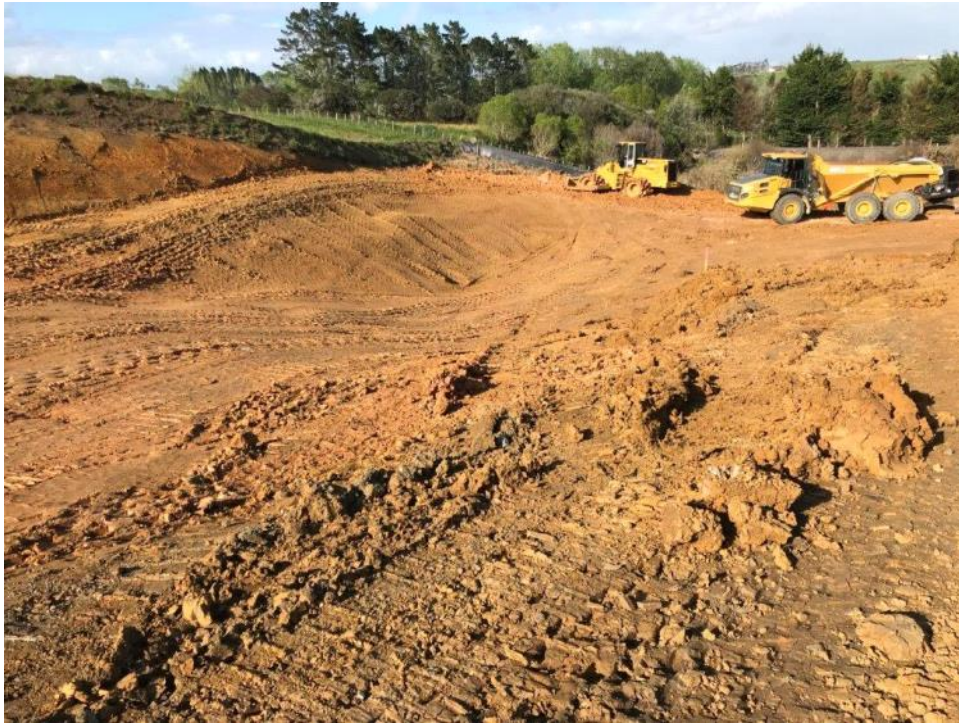
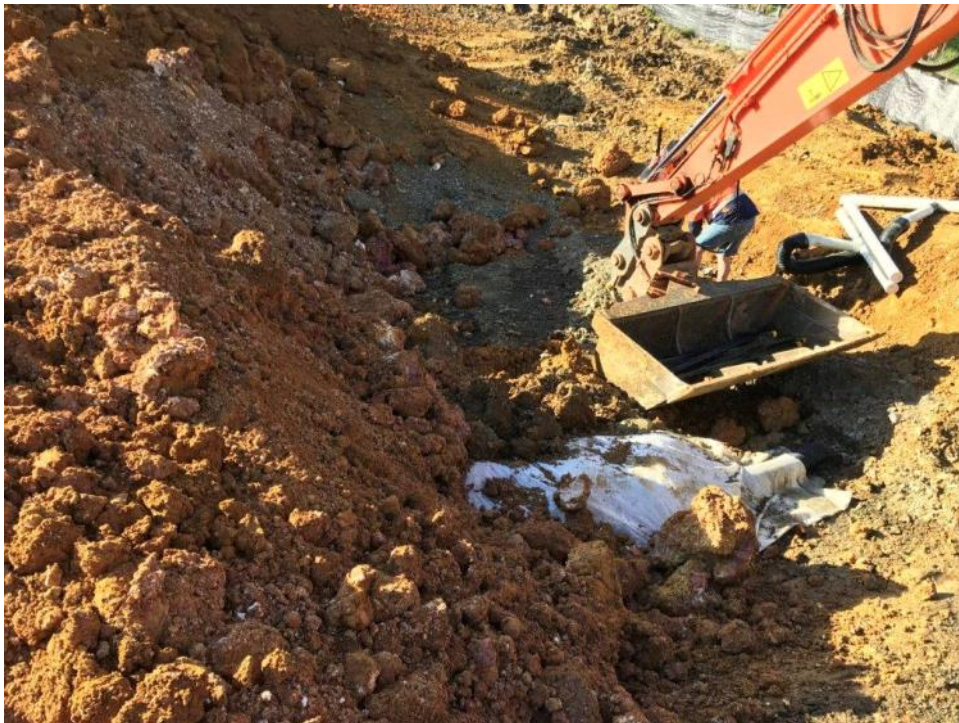
21/10/19

Visited site to check earthworks operations in Fill E/F areas. Toe key has been filled up and tersed since last visit and contractors are beginning to form permanent pond wall.

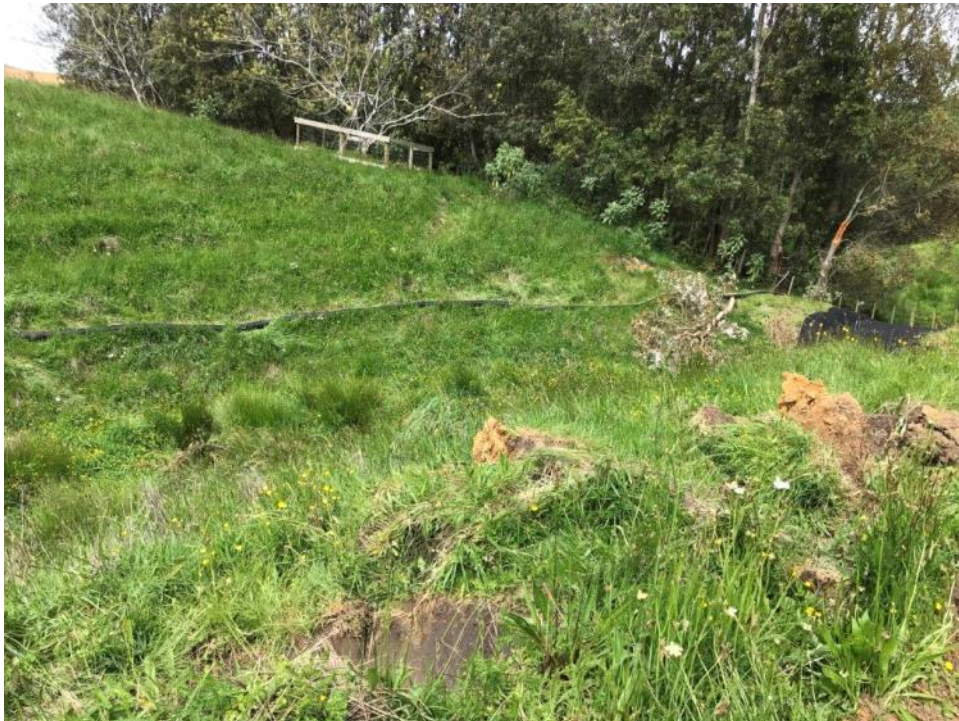
24/10/19 - Fill K

Visited site at request of Dylan (Dines) to inspect stripping in area of Fill K / Cut 2. Only a small area within the area of the silt pond had been stripped back to very stiff natural ground. The gully for Fill K had no been mucked out yet, and no excavations to form the silt pond had been started either.

Discussed with Dylan that we should return to site once the gully is mucked out and we can carry out a shallow trial pit in the area of the proposed toe key prior to excavations.

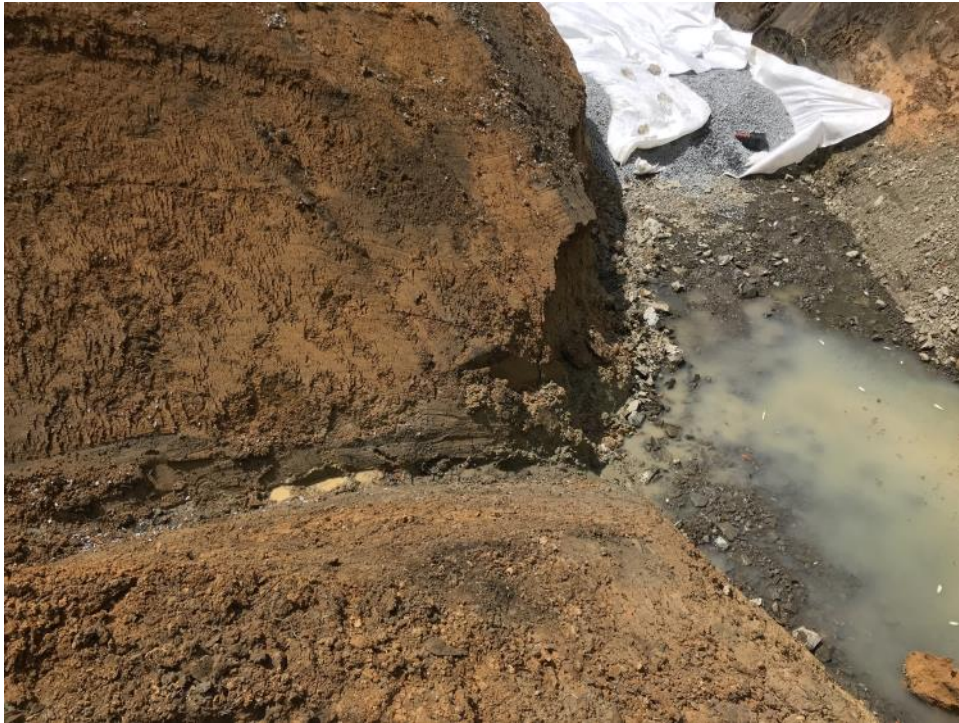
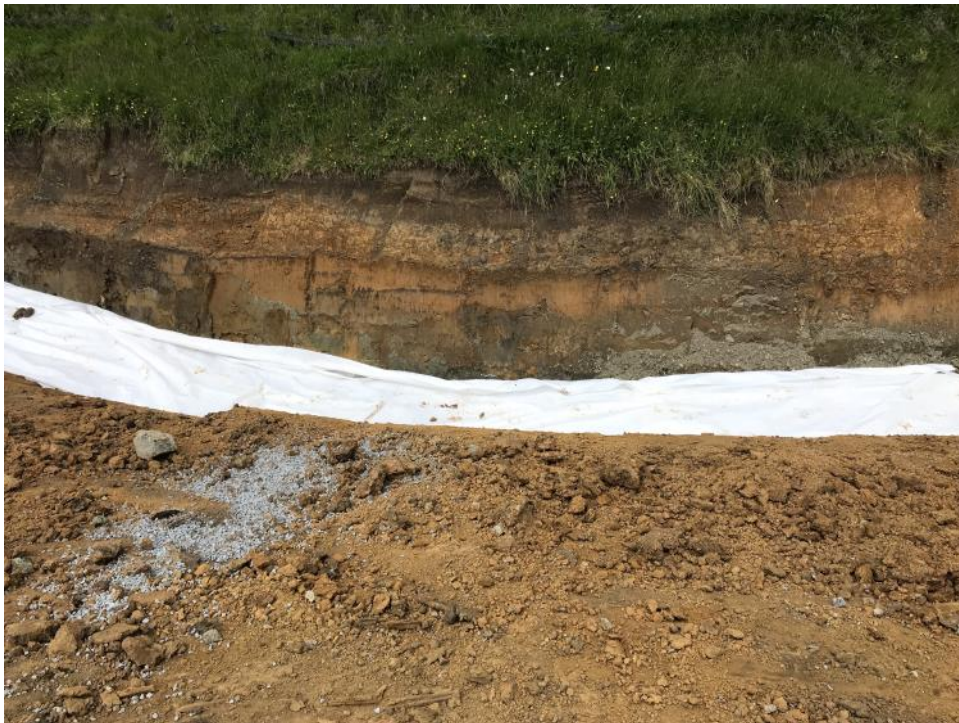
Visited site to observe gully muckout and drain installation. Muckout was deeper than our previous recommendation due to a 1m clay cap needed below the pond.

There is a small area of seepage near the base of the gully muckout which showed some seepage. We recommended that an extra drain is installed here to connect into the main underfill, ensure a 1m clay cap beyond the pond is satisfied. We will prepare a CAN detailing this.

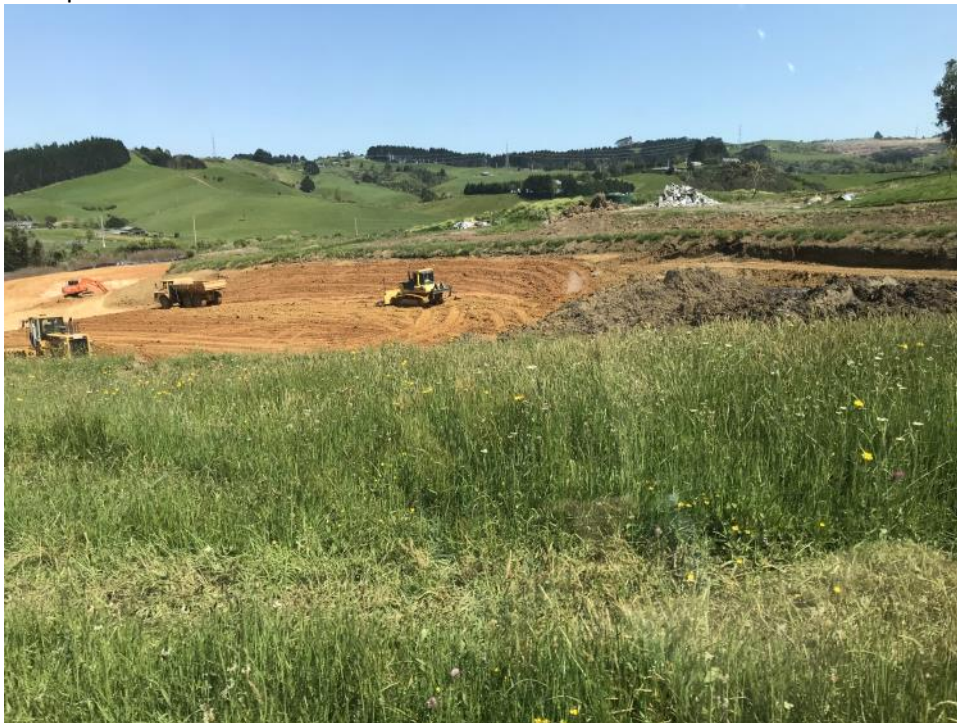
Fill K photos:

While on site we also visited the pond area in Fill K. There are groundwater seepages, however, are at the base of the pond. Advised the contractors they should continue preparing the pond, with the likely outcome being a underfill drain connecting into the primary collector drain.

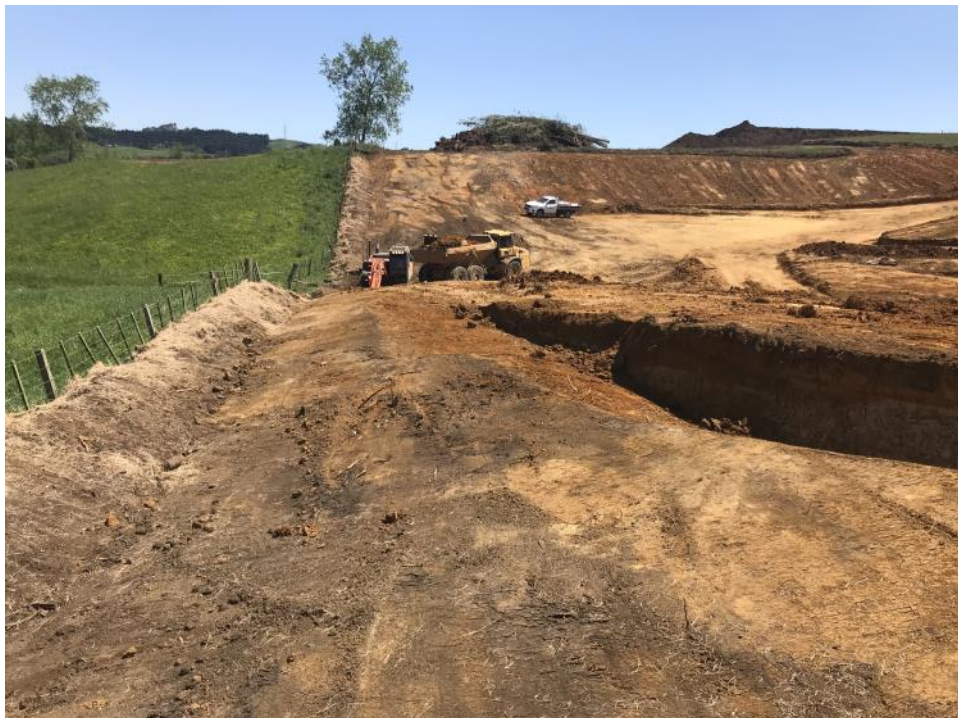
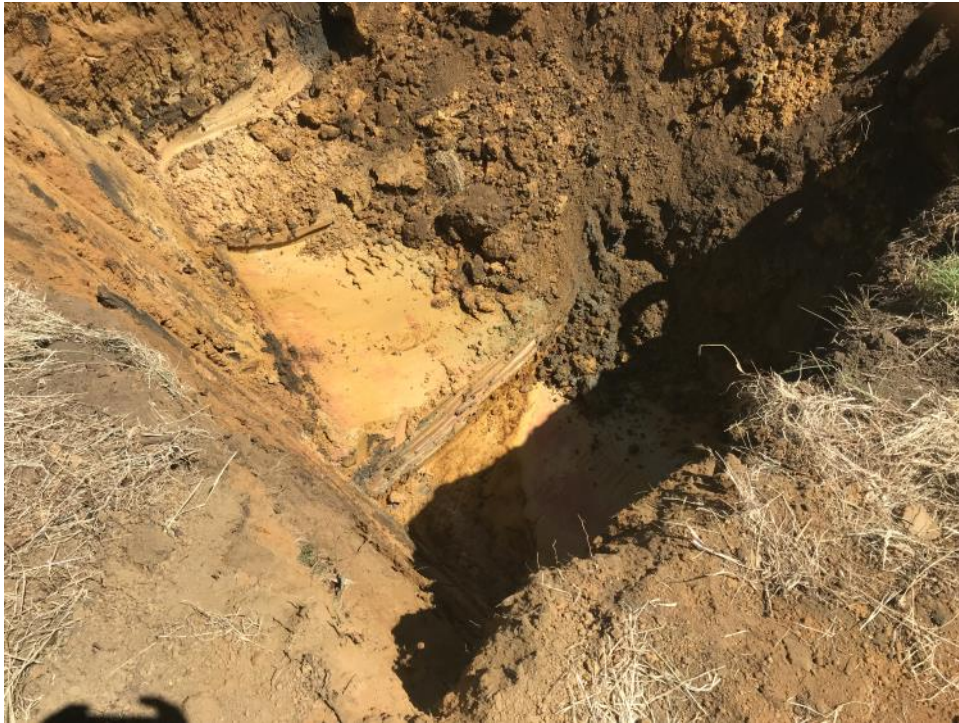
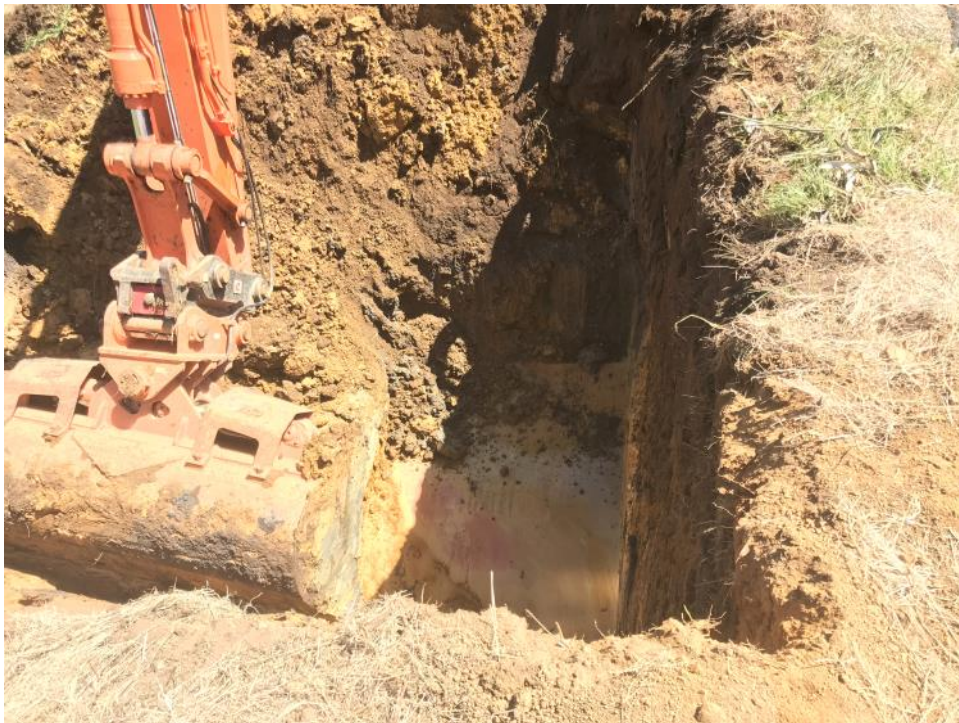
Fill K:

Carried out three trial pits within the area of the shear key and one within the pond area. The ground had been brought down approximately 2m from our previous visit when the initial trial pits were carried out. The additional pits found the hard layer identified during the previous visit at approximately 1m below the top of the pit, and this was proven for approximately 3m beyond this depth (the excavator was struggling to remove the material at the base of the pit with a rock bucket).

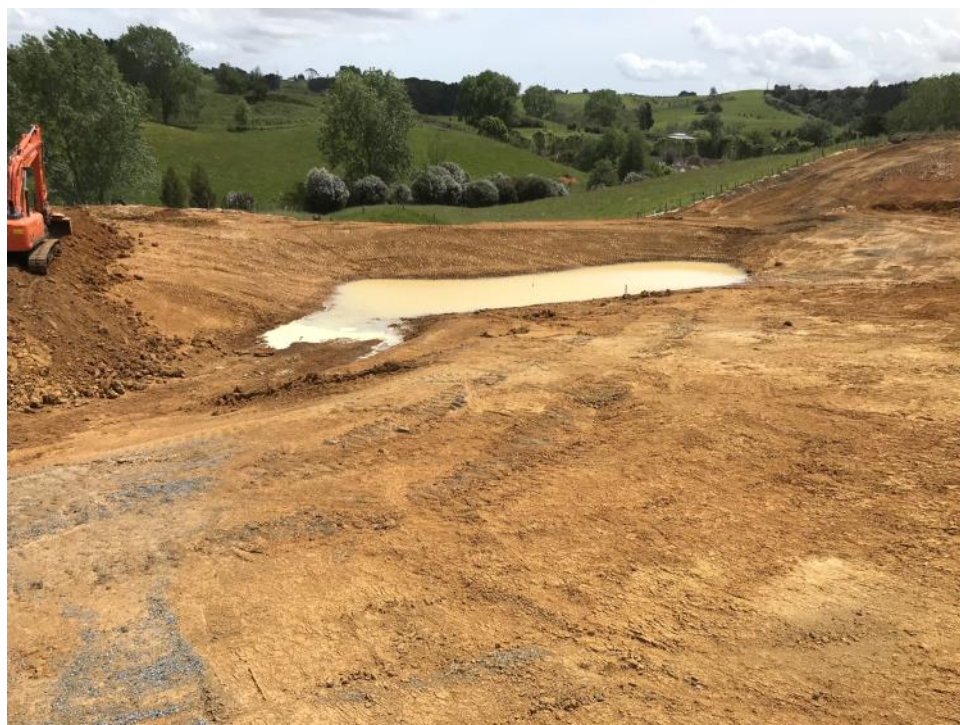
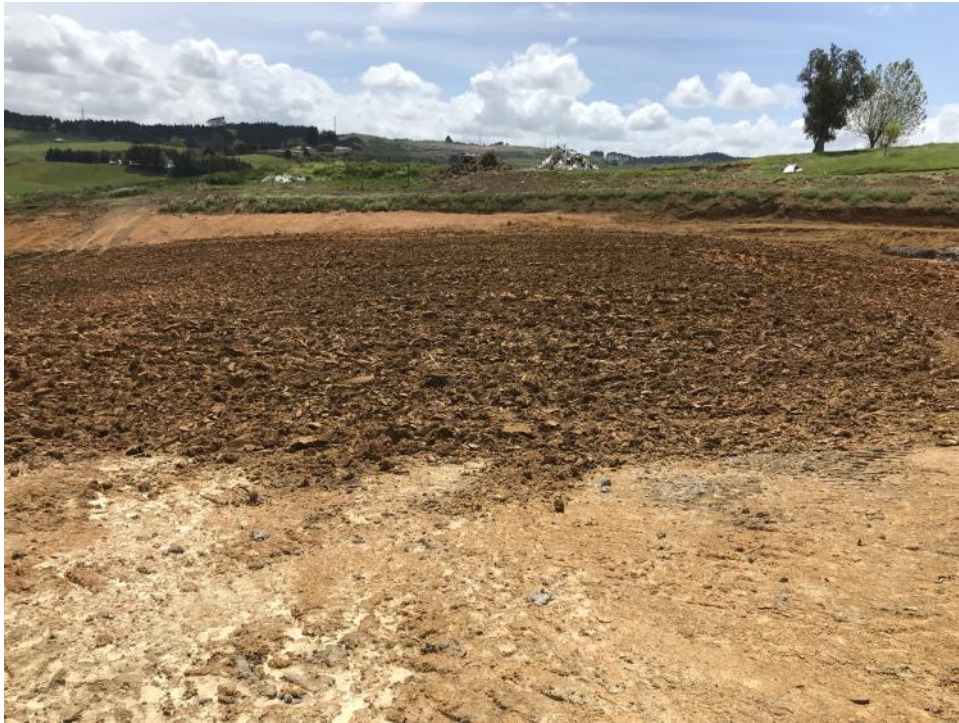
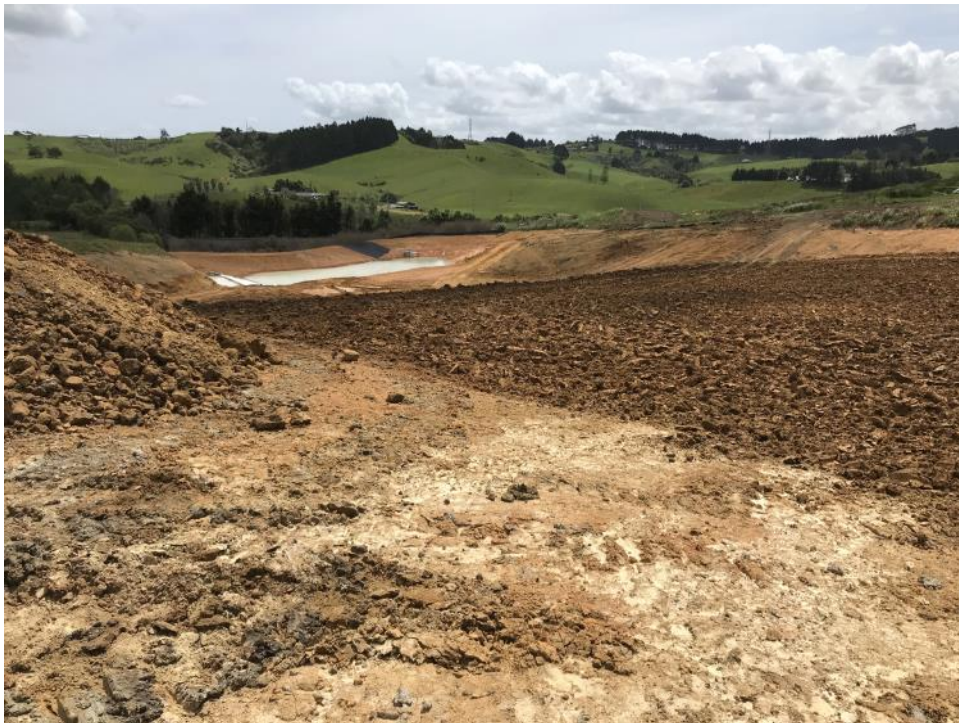
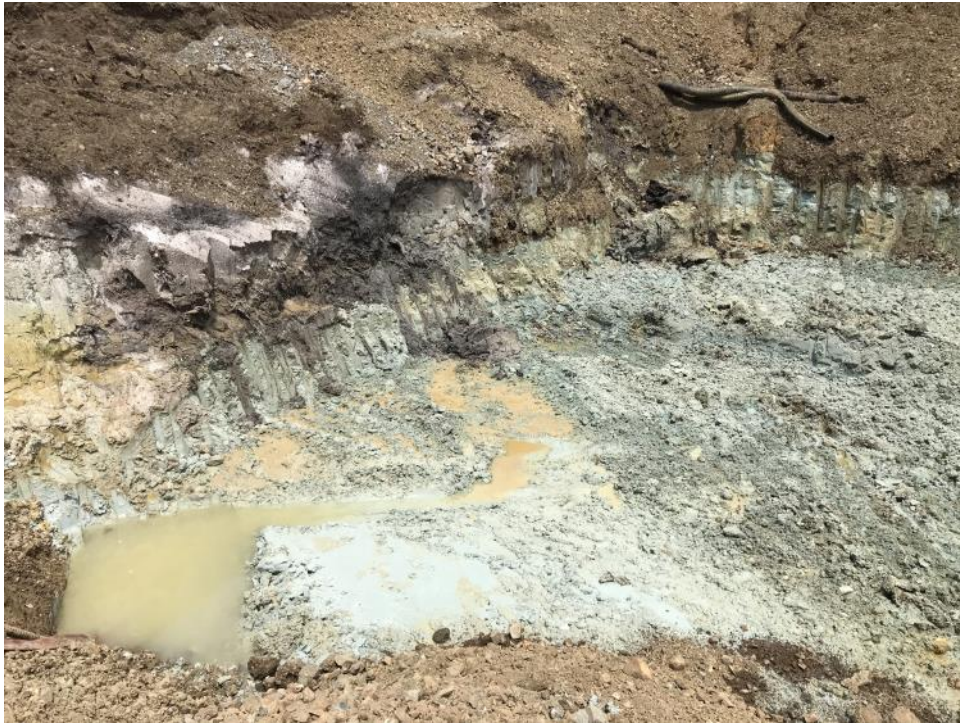
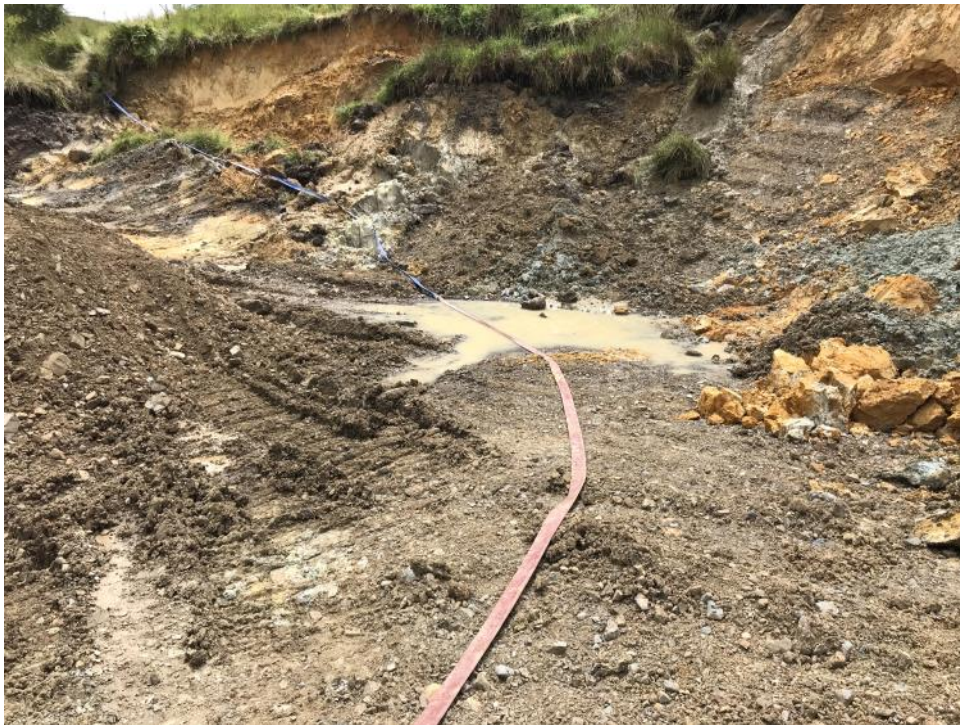
22/11/19 - REB1 pond base

Ground had softened at the base of the pond due to water seepages. Recommended that a nominal undercut of say 0.2m to 0.5m be carried out (based on shallow hand augers drilled), ensuring the area remains drained (i.e. leave the pumps on while filling) to ensure the subgrade stays dry. We will need to inspect the final subgrade and so recommended this should be carried out in small stages with filling operations commencing immediately after we have seen the subgrade.

Also brought up the idea of laying some trenches to catch water seepages. I will discuss this with Chris later and prepare a CAN outlining our recommendations.

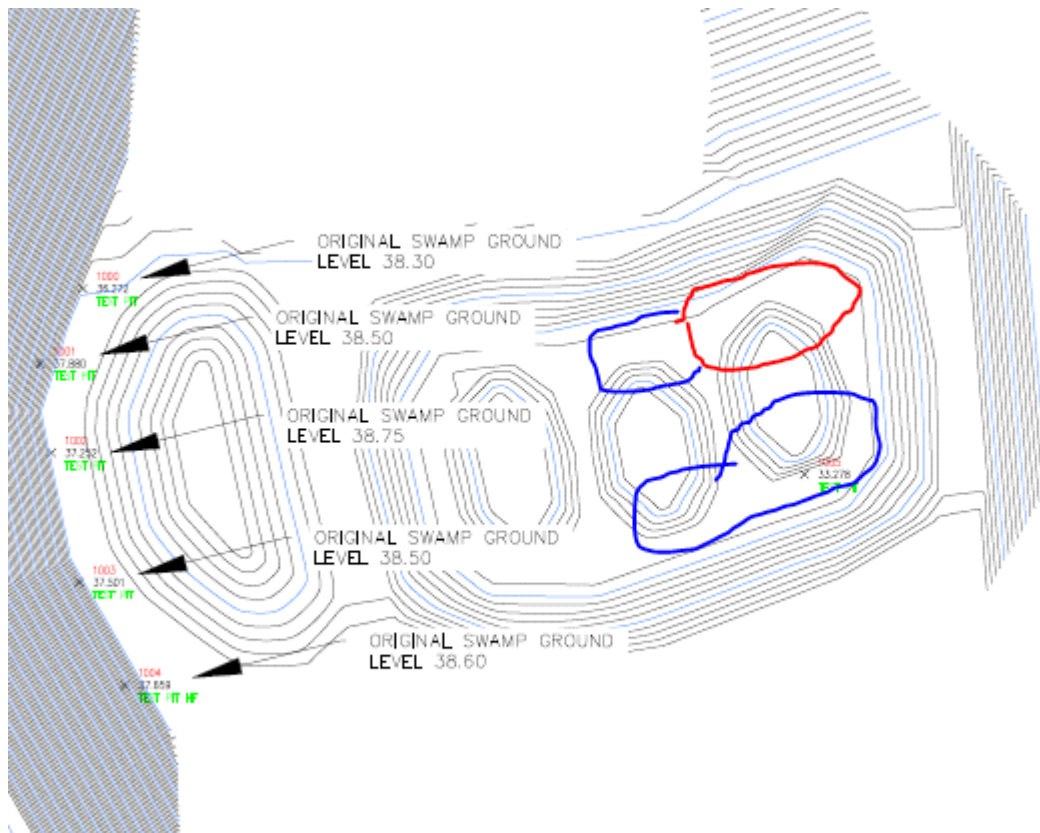
Visited site at request of Dylan to inspect next section of pond base subgrade to fill up to pond invert. Stiff to very stiff, inorganic natural ground exposed throughout (blue). The hardfill track still remains to be removed and we will look at this once they remove this. The area in red was not fully stripped yet, however, several areas were exposed with ground being consistent throughout. Asked contractor to send photos once complete so they commence filling to stabilise a small slip which had formed in the side of the bank.

Also had a look at fill G and Fill E. Fill G and surrounding areas of Cut 2 stripped back to competent natural ground. Fill E near design level. This area currently being used to dry out the wet materials coming from cut 2 pond.

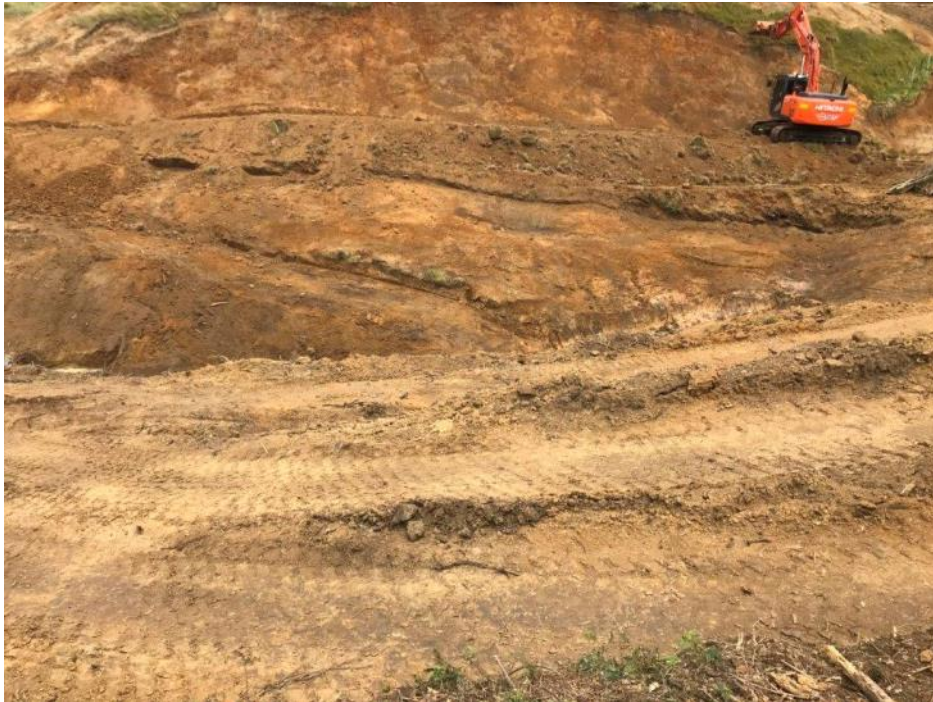
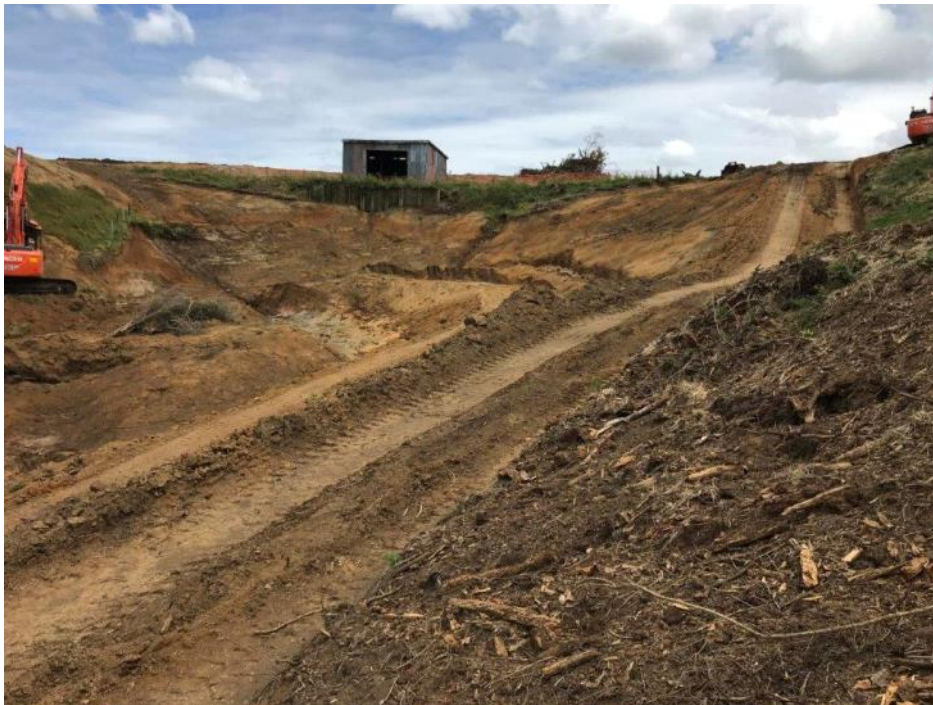
Groundwater seepage

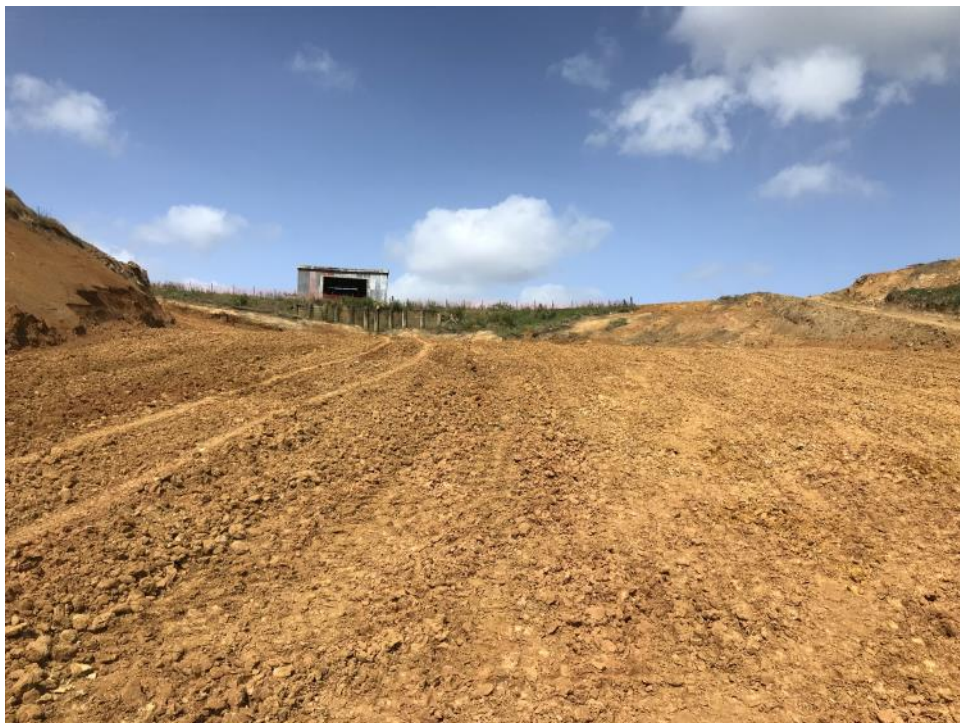
Visited site at the request of Dylan to catch up on site works within the REB1 fill area. Contractors have filled up the areas sighted prior to the Christmas break. They will send through photos showing the removal of soft soils within the gully inverts.

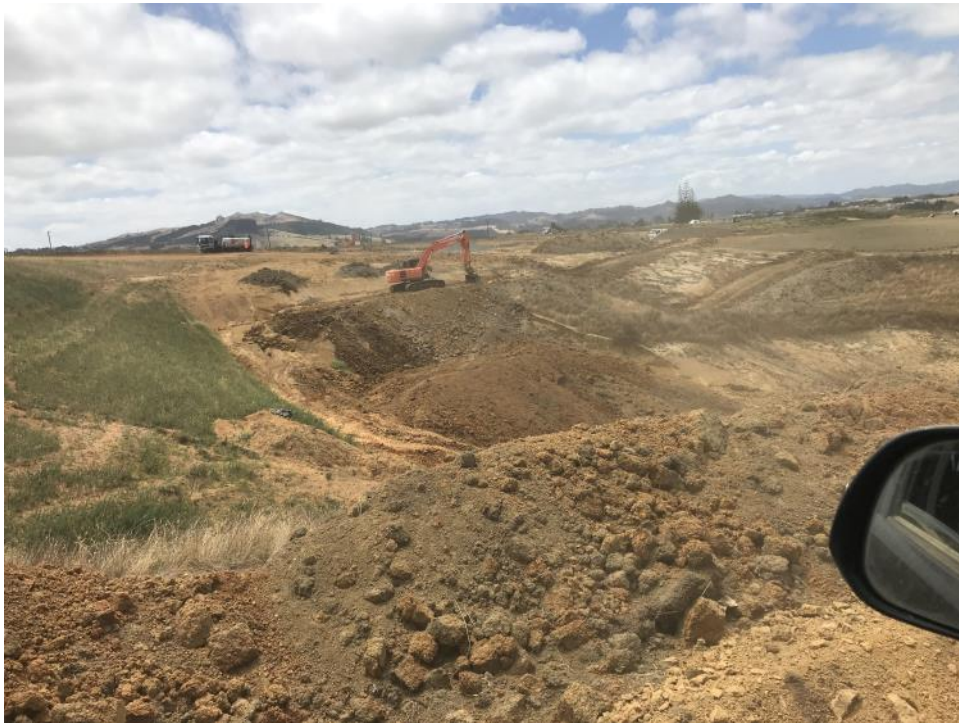
Visited old slip site with Dylan and discussed benching the slip debris out.

Advised Dylan that the slip should be fully benched out to the natural ground (i.e. removing all the slip debris) at which point we can observe and provide further recommendations. This will likely be to recommend a series of benched drains running parallel along the slope with one or two collector drains running along the extend of the slip area. We also advised that the lateral drains be installed within the vicinity of the existing chimney drain as per our design (this was never done during the earlier earthworks stage).

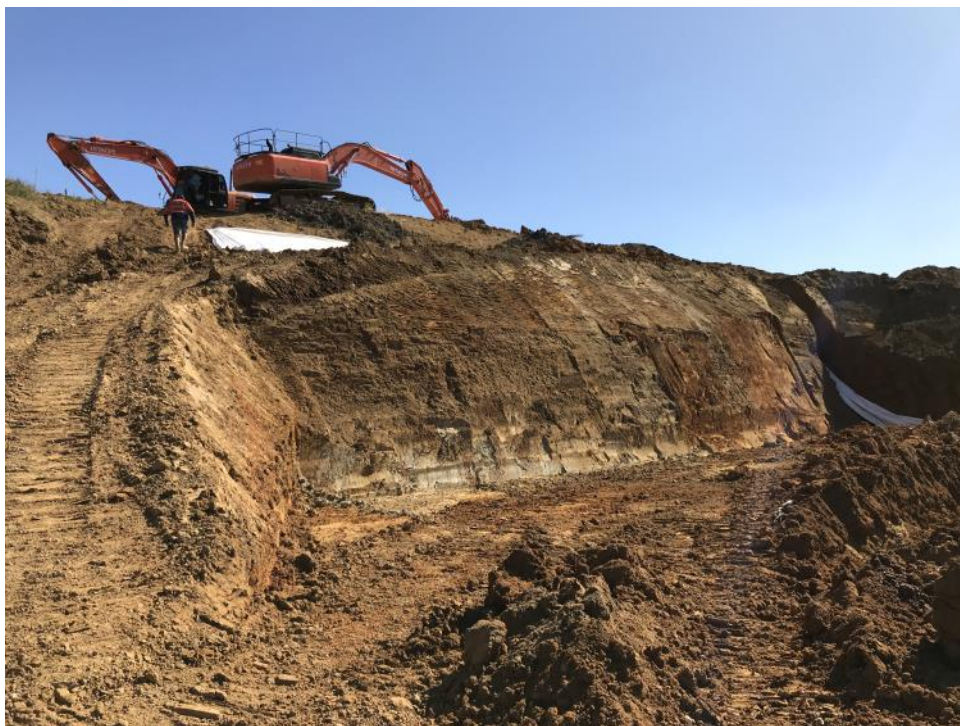
Visited site at the request of Dylan to inspect top two benches into the remediated slip adjacent to REB1. Benches have been excavated into the natural ground and the contractors have further a small trench along the rear face to installed drainage. Attached below is their proposed plan.

Shear key filling still coming up. Photo below.

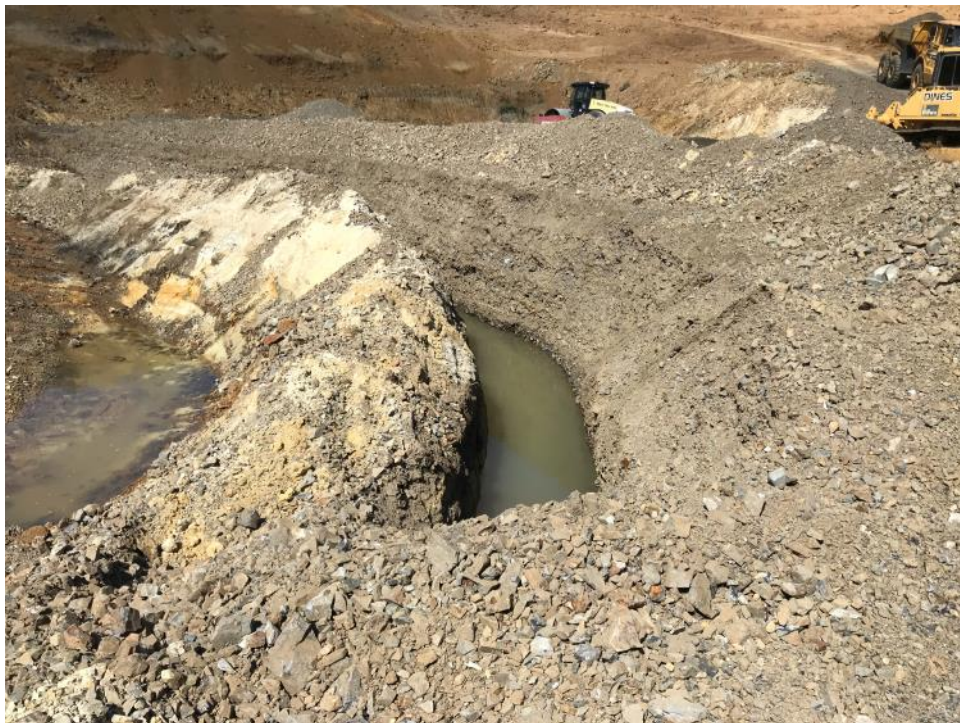
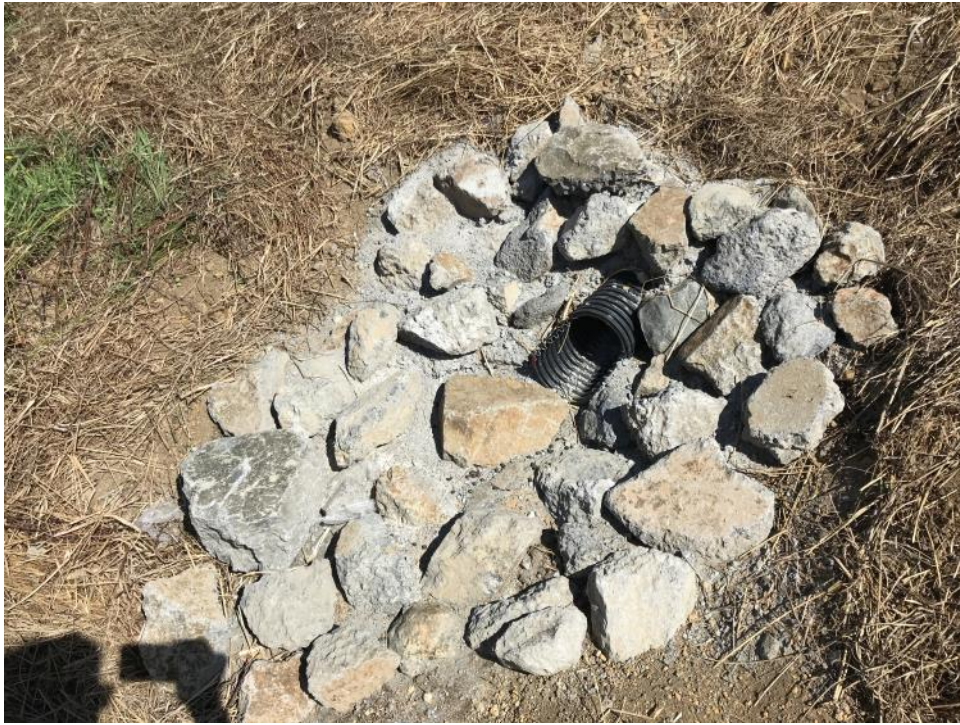
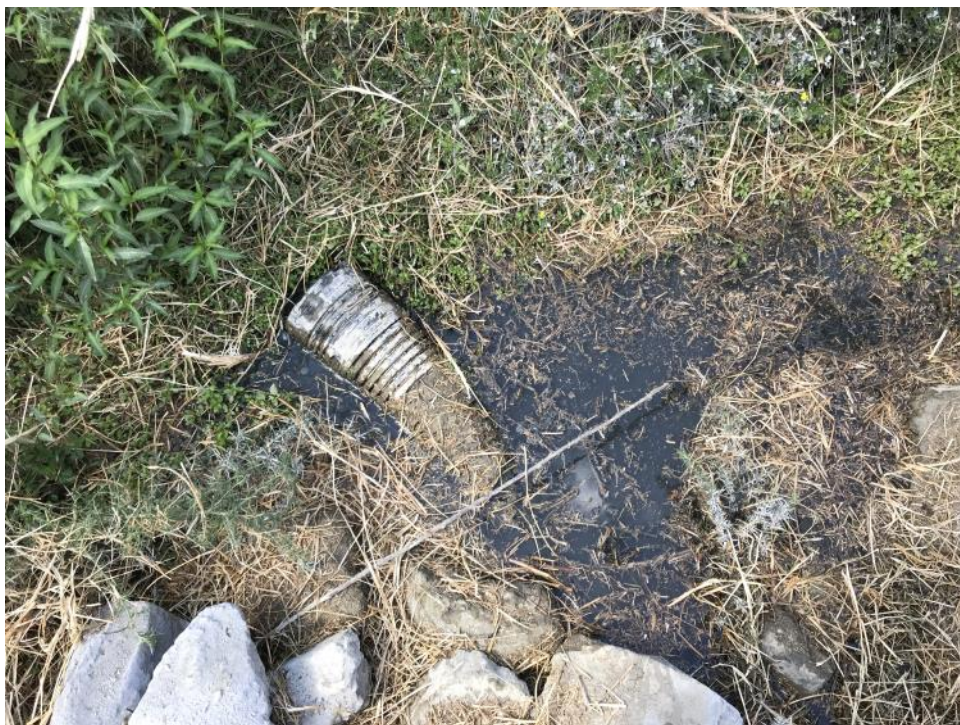
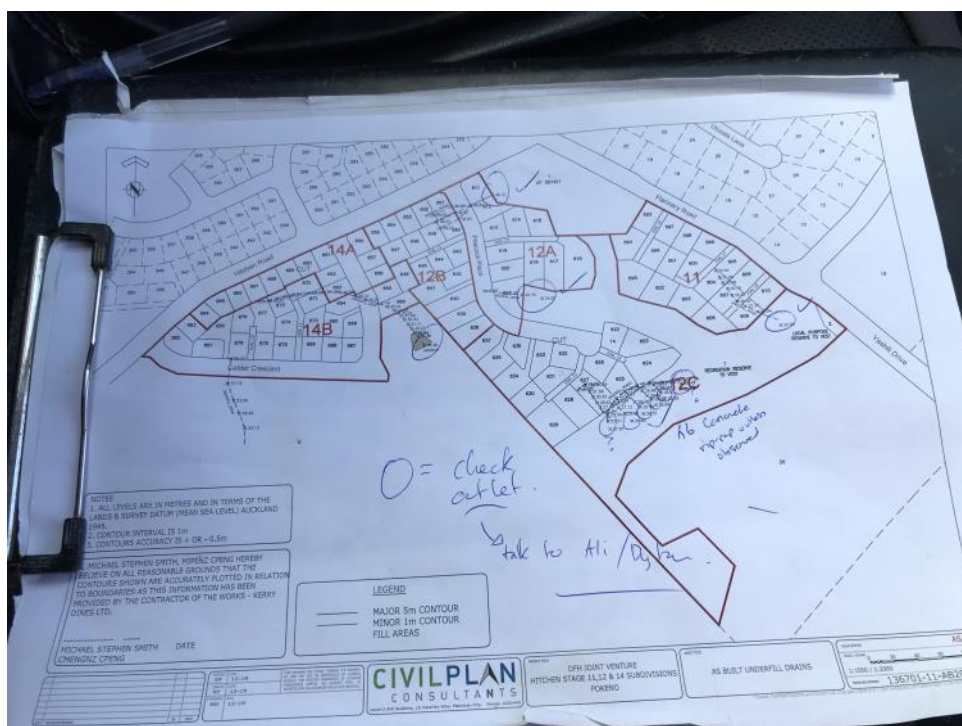
06/03/20

Visited site to check in on shear key. The contractors are excavating the 2m beyond the fill batter now. Will return to site with Chris early next week to REB requirements.

Also checked outlets for Hitchen 11, 12, 14 GCR. All outlets correctly formed with concrete rip rap.

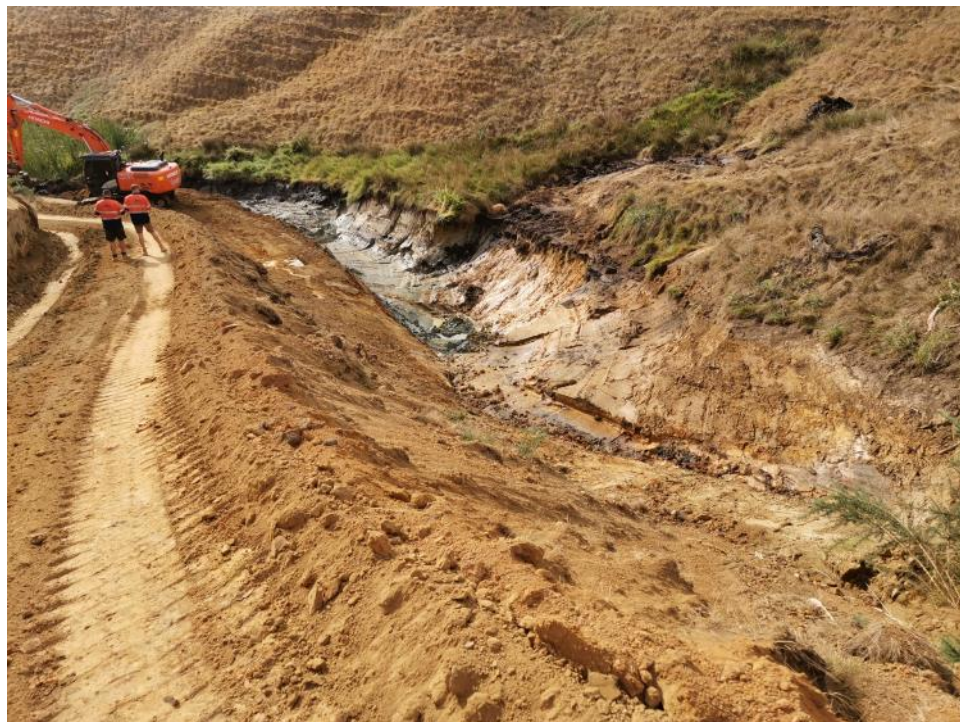
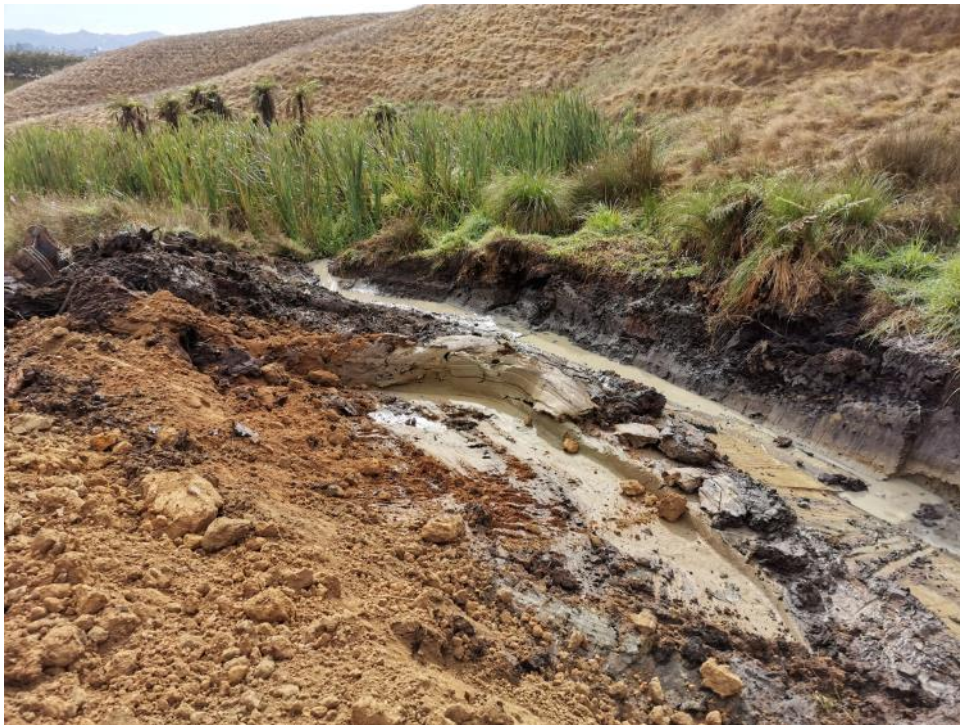
10/03/20

Visited site at the request of Dylan to inspect first gully muckout for Fill B. Generally stiff ground is exposed at the base of the gully. The contractor was advised to strip wet/softer ground where encountered.

Also discussed installing another underfill drain up the gully branches as there has been some groundwater seepage / slippage observed which the contractor has cleared out prior to our visit. Advised we can look at this which stripping operations commence in this area.
