Geotechnical Completion Report

HITCHEN BLOCK STAGE 13A

DFH JOINT VENTURE LIMITED

16 August 2021

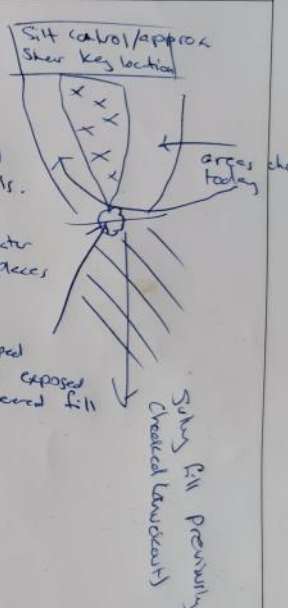
SITE INSPECTION RECORD	
Project no. and name: <u>300113 Hitchen Block</u>	Date & Time: <u>29.4.20</u> <u>9am</u>
Client/contractors present: <u>Dylan (Dines)</u>	Lander staff: <u>1cm</u> SV no: <u>SV2396</u>
Plant operating: <u>1x 20T excavator</u>	
Inspection for (tick all that apply): Shallow Foundations <input type="checkbox"/> Pile Foundations <input type="checkbox"/> Site Meeting <input type="checkbox"/> Subgrade <input checked="" type="checkbox"/> Retaining Wall <input type="checkbox"/> Other <input type="checkbox"/>	
Observations/Notes: <ul style="list-style-type: none"> - Visited site at the request of Dylan to inspect gully mudcut for REG 2 underfill drain. - Generally stiff (loose) soils exposed at base of gully. Inorganic AZ soils. - Contractor also advised that steep-groundwater seepages were obs noted in several places coming from the gully flanks. <div style="text-align: right;">

Discussions/Recommendations given: <ul style="list-style-type: none"> - Recommended some of the silt/liner soils be shipped back ~0.5m prior to placing underfill drain. - Also recommended that localized seepages be topped by collector underfill drains where observed and connected to main underfill gully drain.

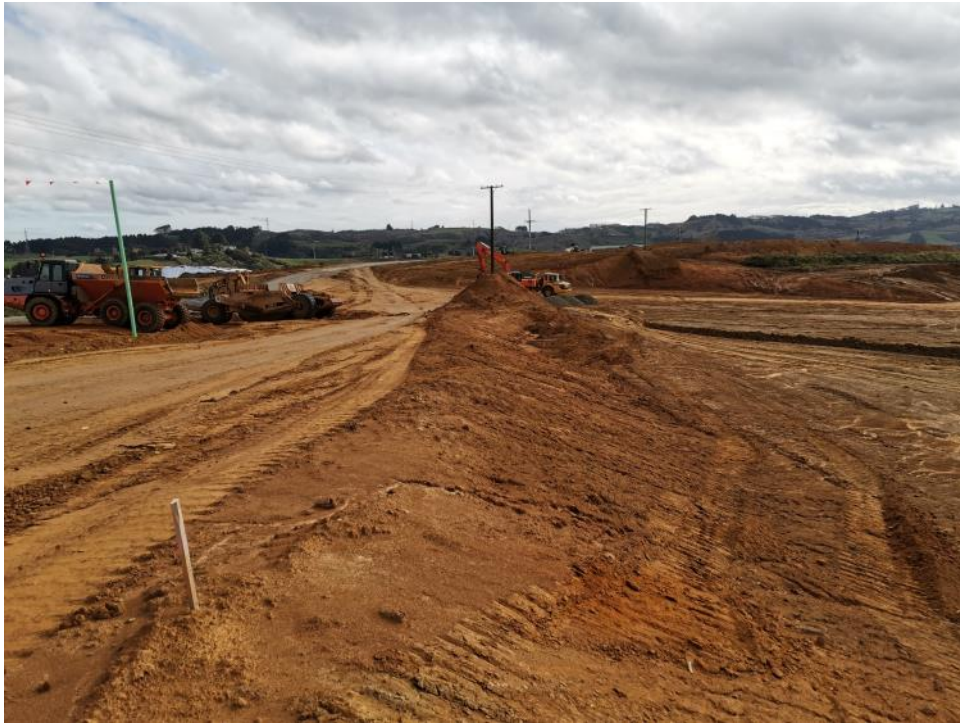
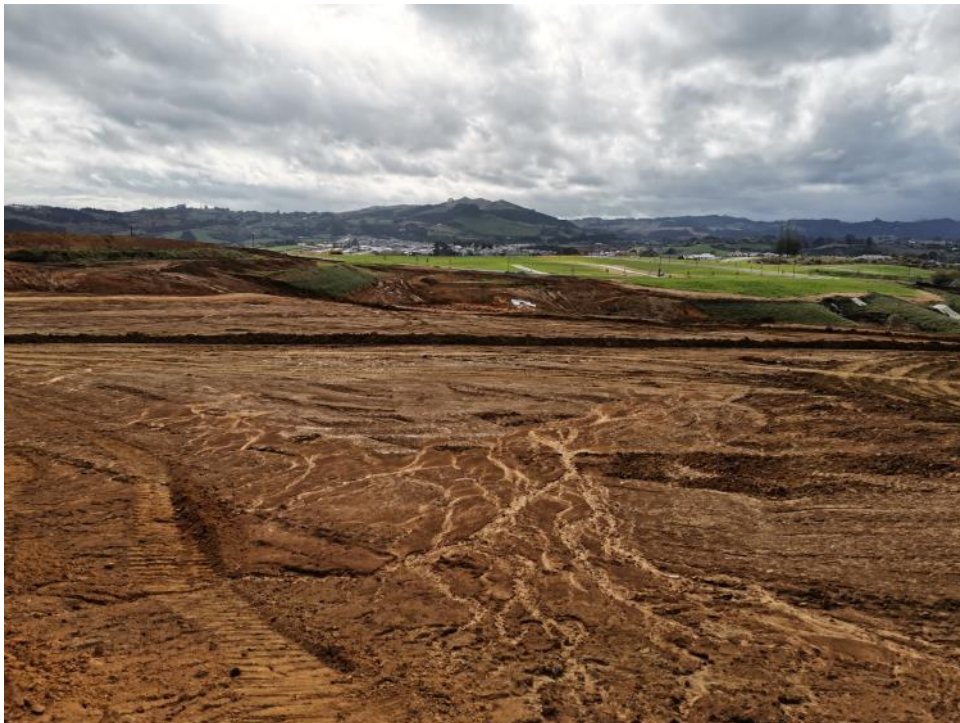
13/03/20

Project no. and name: J00113 - Hitchen Block		Date & Time: 13/5/20 11:30am
Client/contractors present: Dylan (Dines)		Lander staff: km SV no:
Plant operating:		
Inspection for (tick all that apply): Shallow Foundations <input type="checkbox"/> Pile Foundations <input type="checkbox"/> Site Meeting <input type="checkbox"/> Subgrade <input type="checkbox"/> Retaining Wall <input type="checkbox"/> Other <input checked="" type="checkbox"/> REB 1 shear key		
Observations/Notes: - Visited REB 1 area at the request of Dylan. Contractors have filled the shear key to final height with SPR. Next plans are to install the lateral drains perpendicular to the slope face and they will then connect into the rear blanket drain. → Next the initial layer of grid will be placed and OAP65 will be used for the first 1m lift. - Discussed with CE while on site (phone) issues about how to place the grid as the MSE wall/batter starts to cut away from the batter face. Chris has gotten in touch with Cirtex. In the meantime the contractor has been advised to overlap the grid by a minimum of 200mm and place extra layers if and when the grid separates (doesn't overlap) if they don't want to wait for advice from Cirtex.

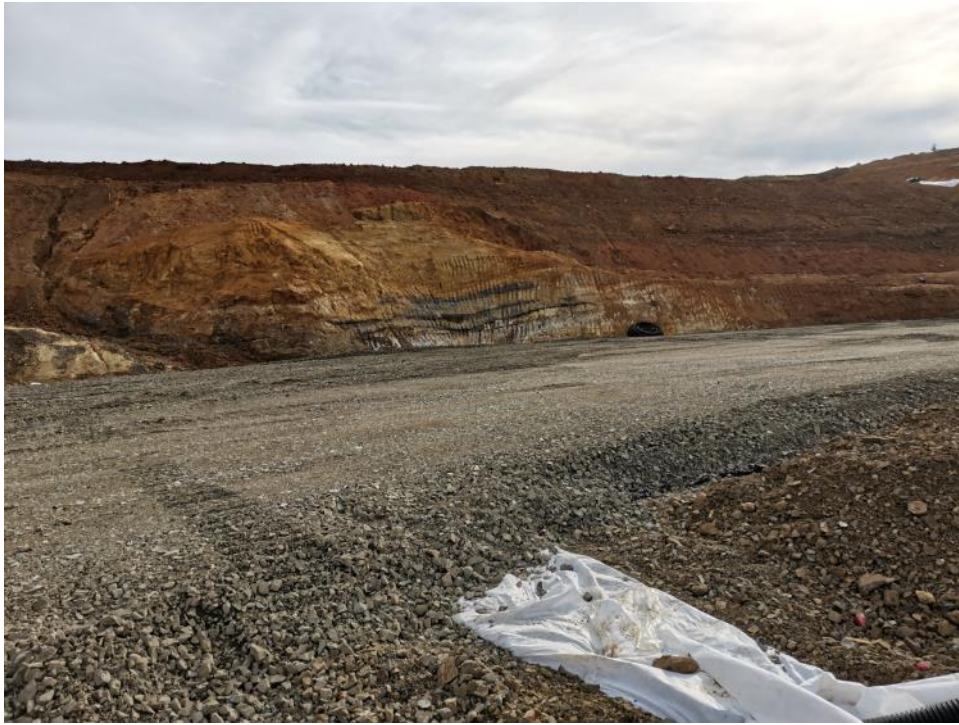
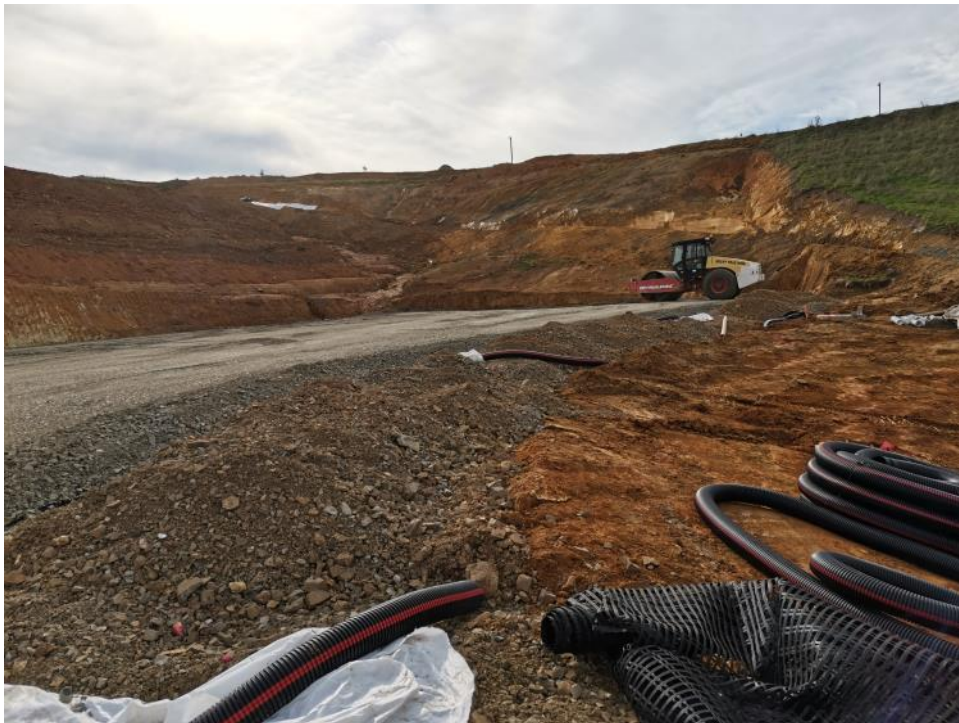
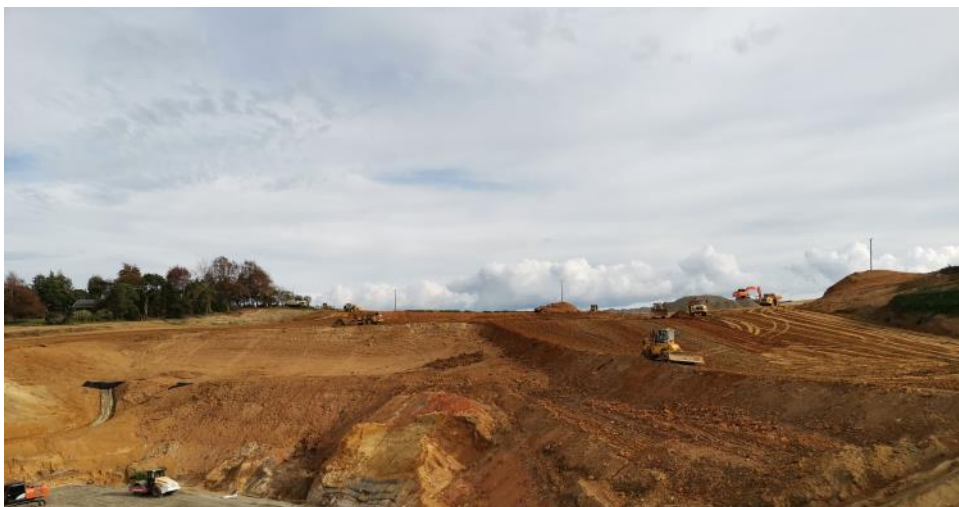
15/05/20

SITE INSPECTION RECORD	
Project no. and name: J00113 - Hitchen Block	Date & Time: 15/5/20 - 2:30pm
Client/contractors present: —	Lander staff: km SV no:
Plant operating:	
Inspection for (tick all that apply):	
Shallow Foundations <input type="checkbox"/>	Pile Foundations <input type="checkbox"/>
Subgrade <input type="checkbox"/>	Retaining Wall <input type="checkbox"/>
Site Meeting <input type="checkbox"/>	
Other <input checked="" type="checkbox"/> REB I Shear Key	
Observations/Notes:	
<ul style="list-style-type: none">- Visited site to observe site earthworks for the completion of the REB I Shear Key.- Lx underfill drains fully wrapped and backfilled with drainage aggregate sighted at both the front and rear faces of the shear key.- Currently rollers are compacting GAPS, which comprises the first 1m of the REB batter.- Will return to site with CE on Monday to observe geosrid placement.	
Discussion/Recommendations given:

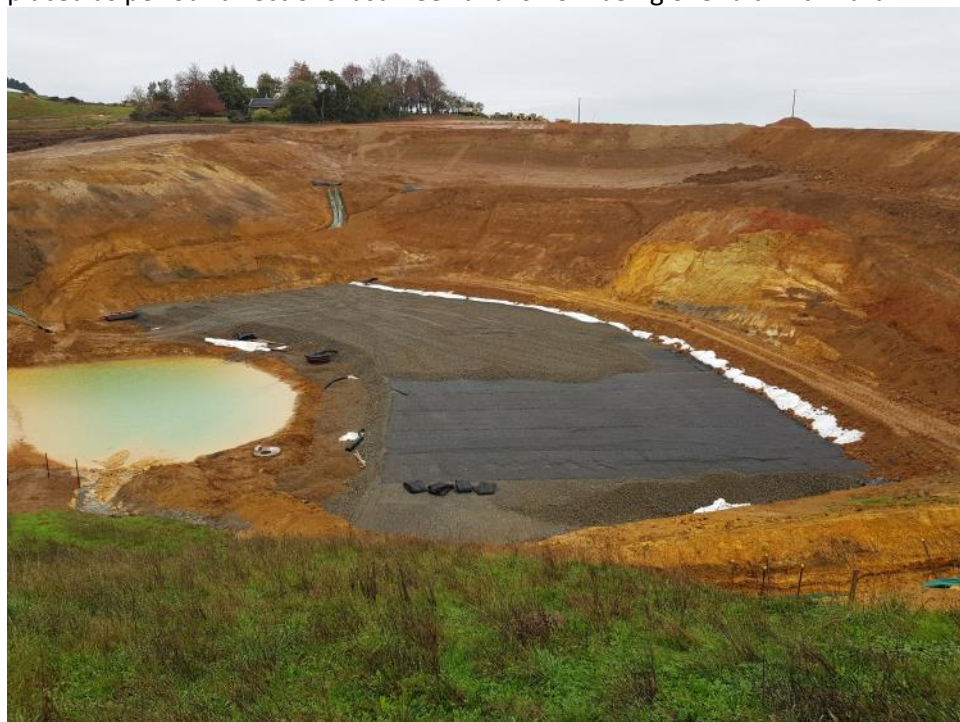
24/06/20

Quick stop by to see progress of REB1. Looks like they have stopped due to the weather.

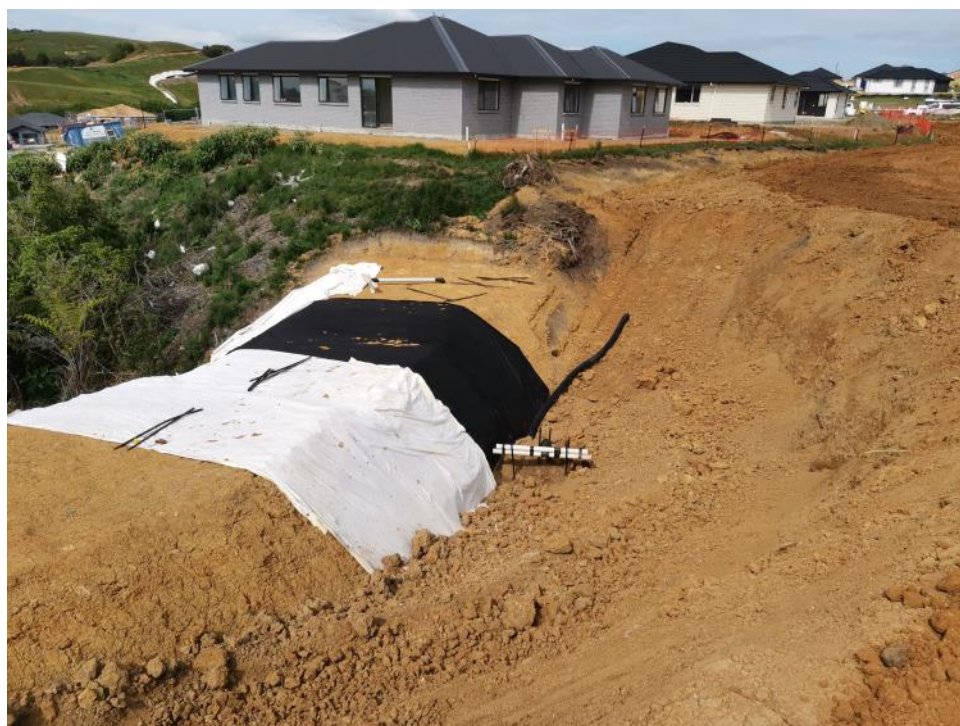
Earthworks are also commencing in the large slip area at the far end of the site. Silt controls are currently being formed for these works prior to stripping operations commencing.

In Stage 12D, earthworks filling operations are progressing, and the underfill drain is likely to be extended in the next week or two.

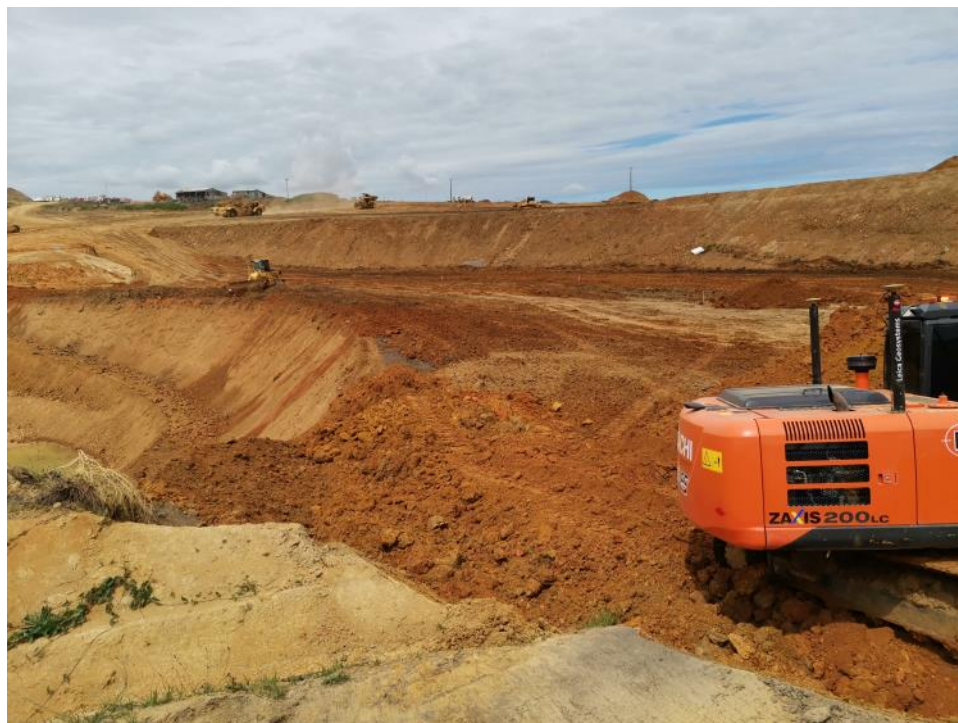
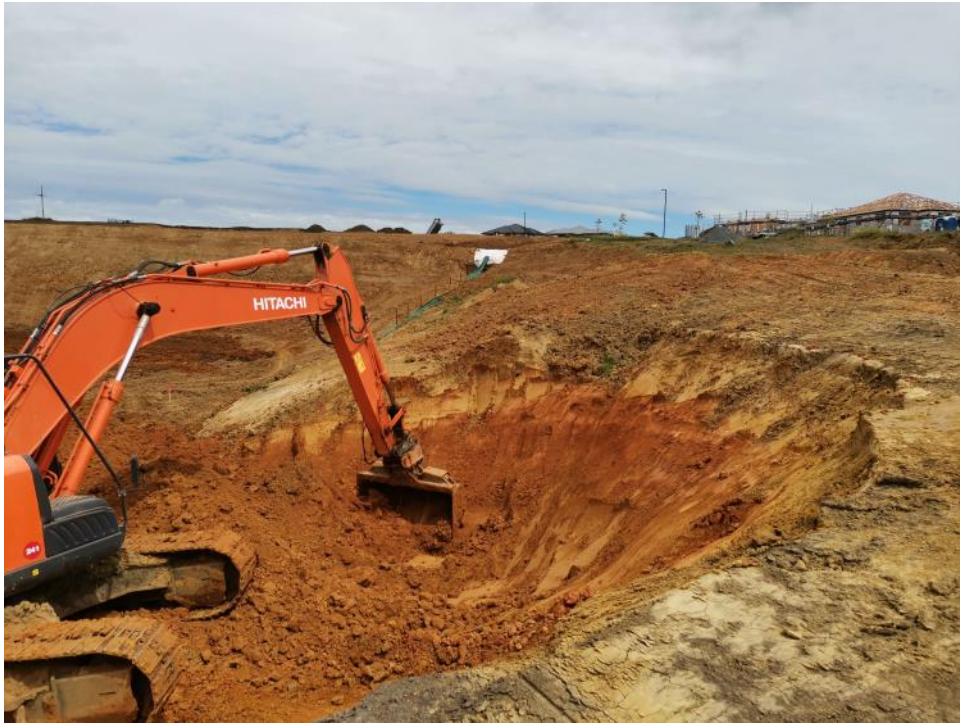
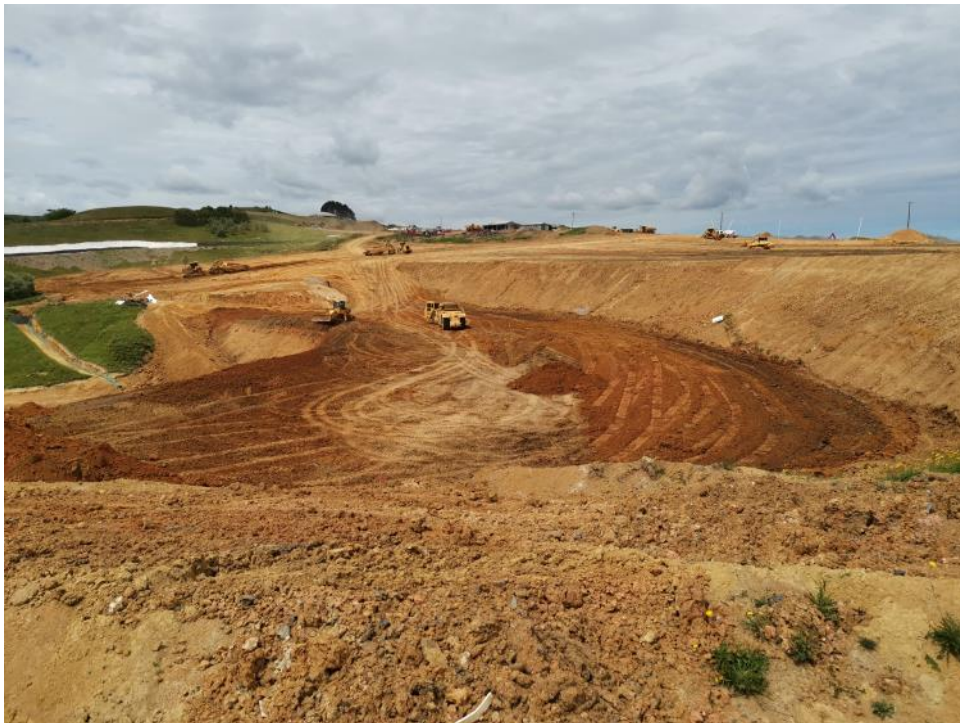
Visited site to observe earthworks operations in REB1. The REB is now up to chainage 49.5 and a layer of intermediate grid had just been placed and covered by clay. The next bench was being prepared at the time of inspection. Contractor informed that the next grid would likely be placed tomorrow morning so will do another inspection of the grid then.

Was also informed that the lateral drain was trenched and installed mid-last week, for which we received the as-builts. Advised we should try inspect the next section of drainage installation if possible.

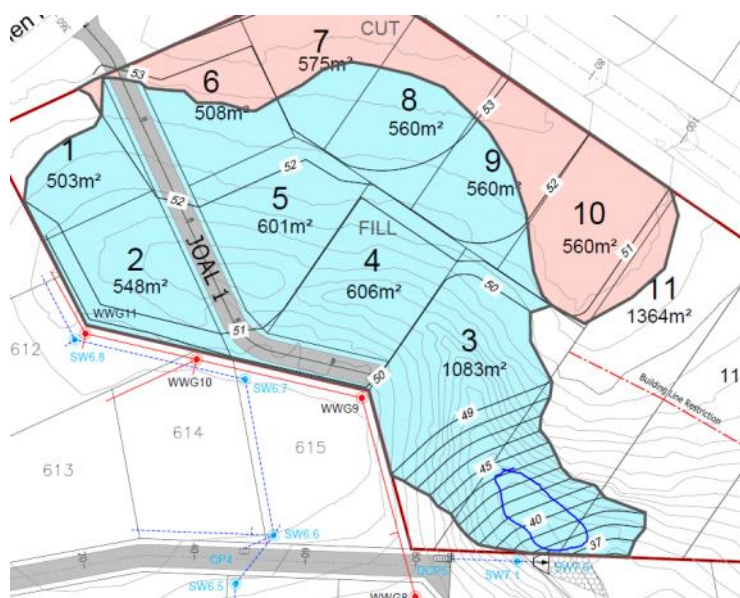
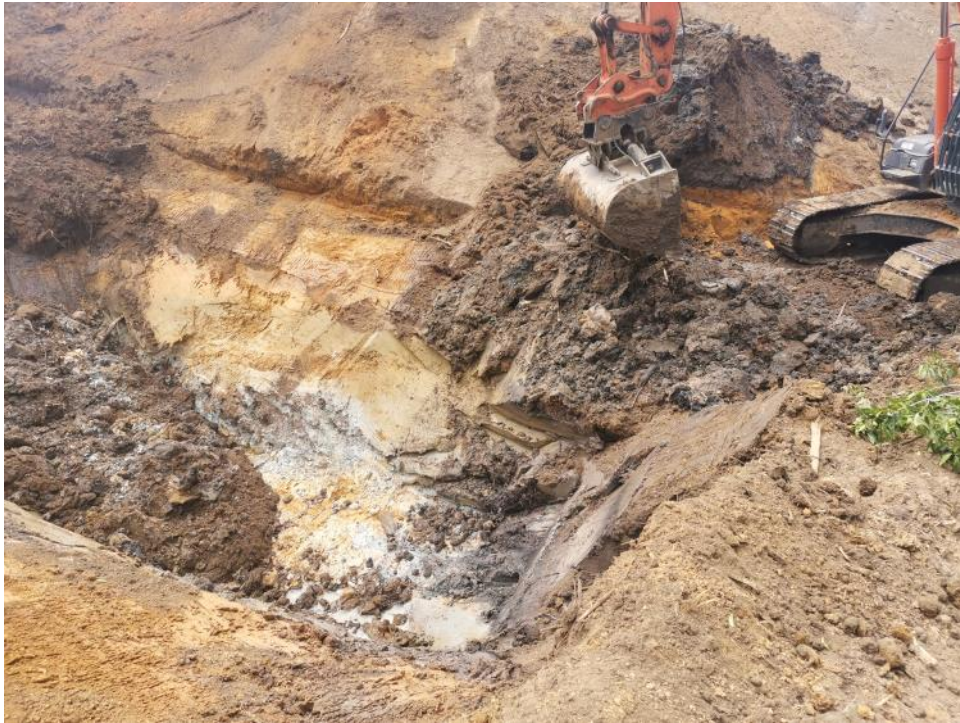
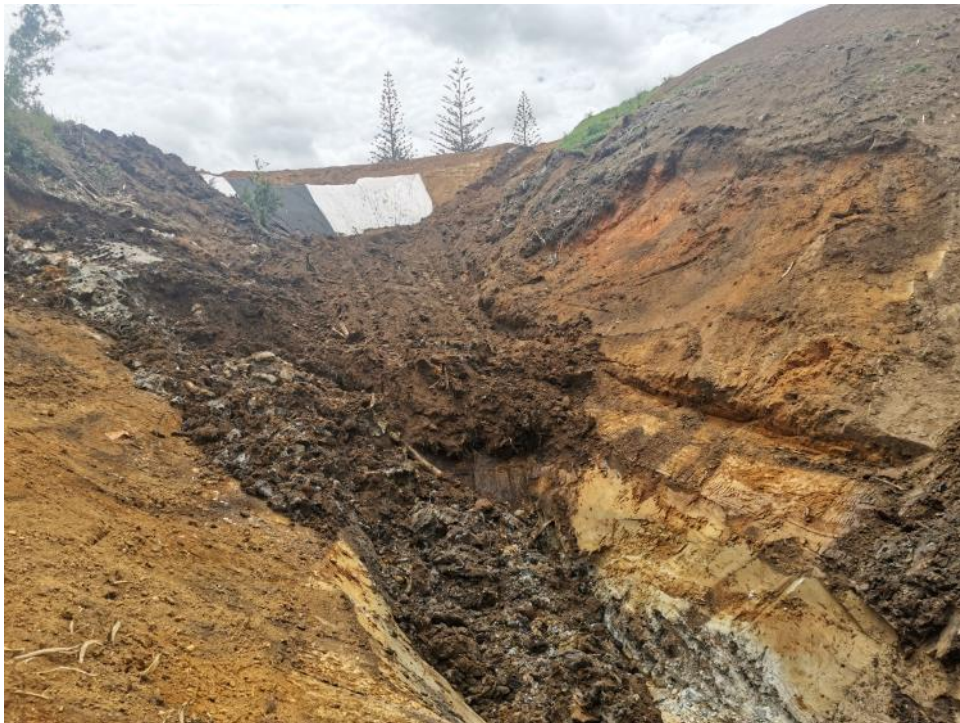
16/11/20 - PM - Stage 12D

Visited site to observe the gully muckout within Stage 12D. The muckout is commencing from the lower portion of the gully and will tie in with the existing underfill drain once some engineered fill has been placed in the area to allow digger access. Approx. area sighted shown in blue annotation below. Will return to site tomorrow to observe progress here.

Also inspected the removal the stockpile materials within Fill D. Very stiff, orange/brown ash soils were exposed consistent with the stripped soils previously sighted within the adjacent cut areas.

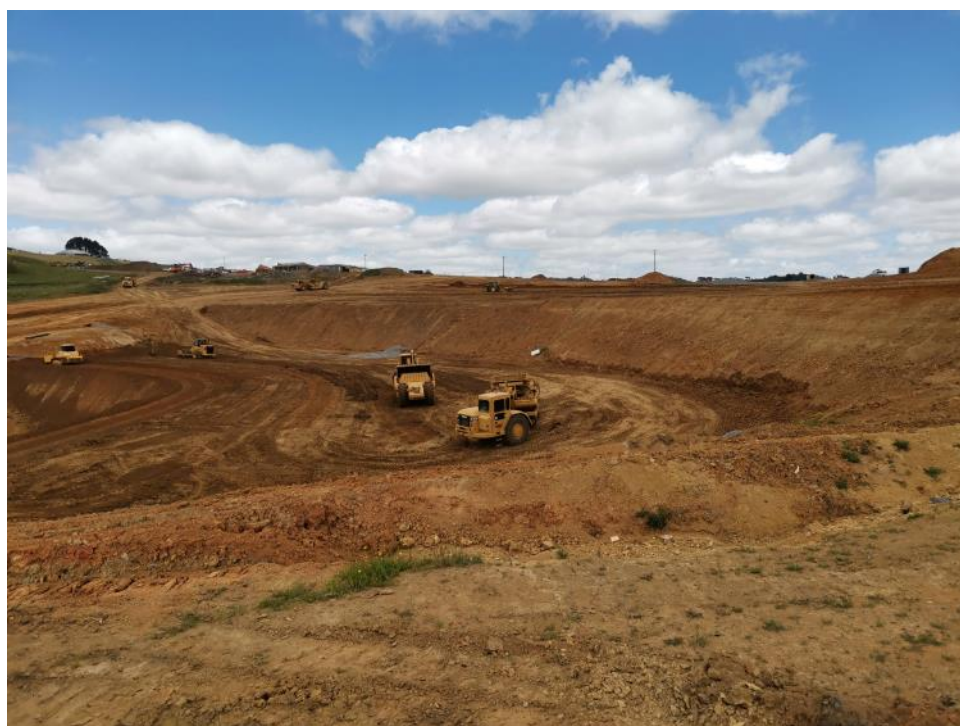
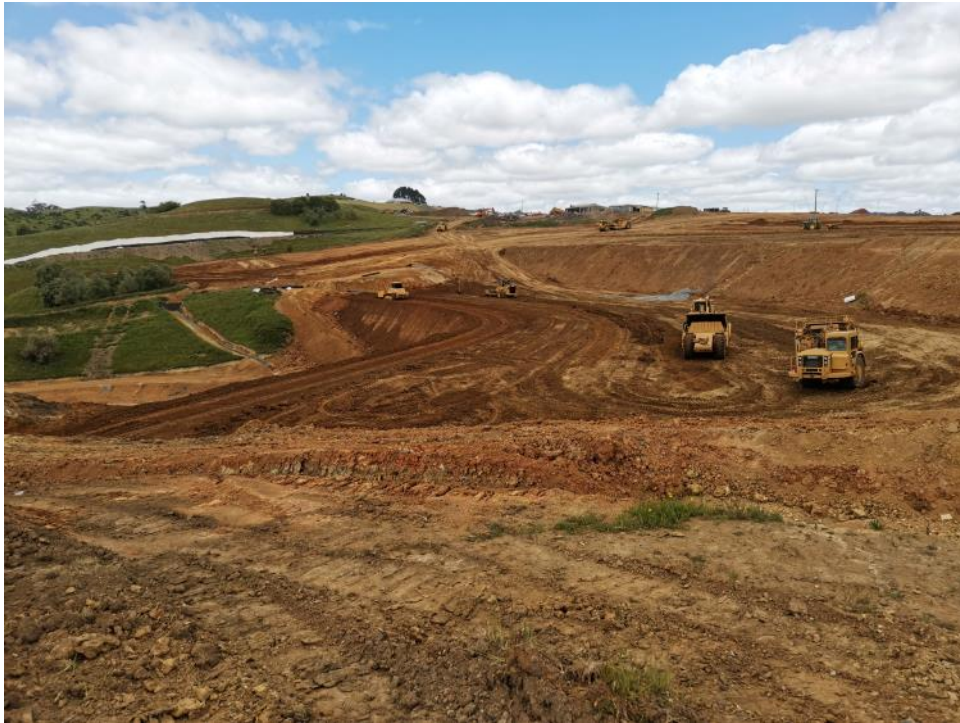
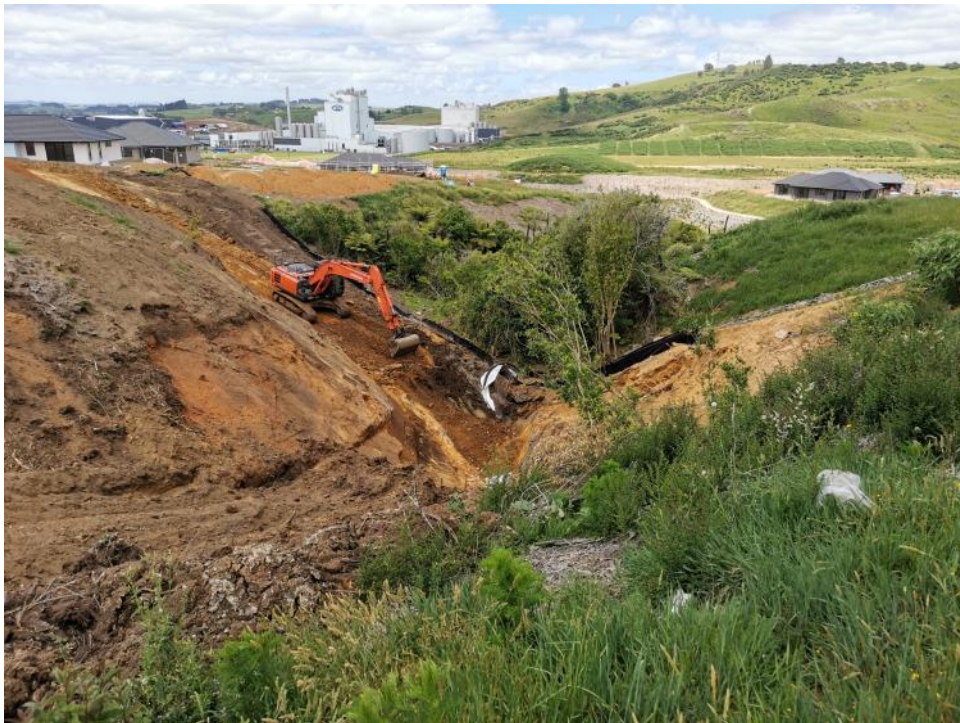
17/11/20

Visited site to observe general earthworks operations. Within Stage 12D the base of the gully had been mucked out slightly further upslope and the drain coil and bidim cloth were in place at the base of the muckout. SPR was being placed over the drain to be compacted.

Within REB1 clay fill was still being compacted. It appeared that the geogrid had already been placed.

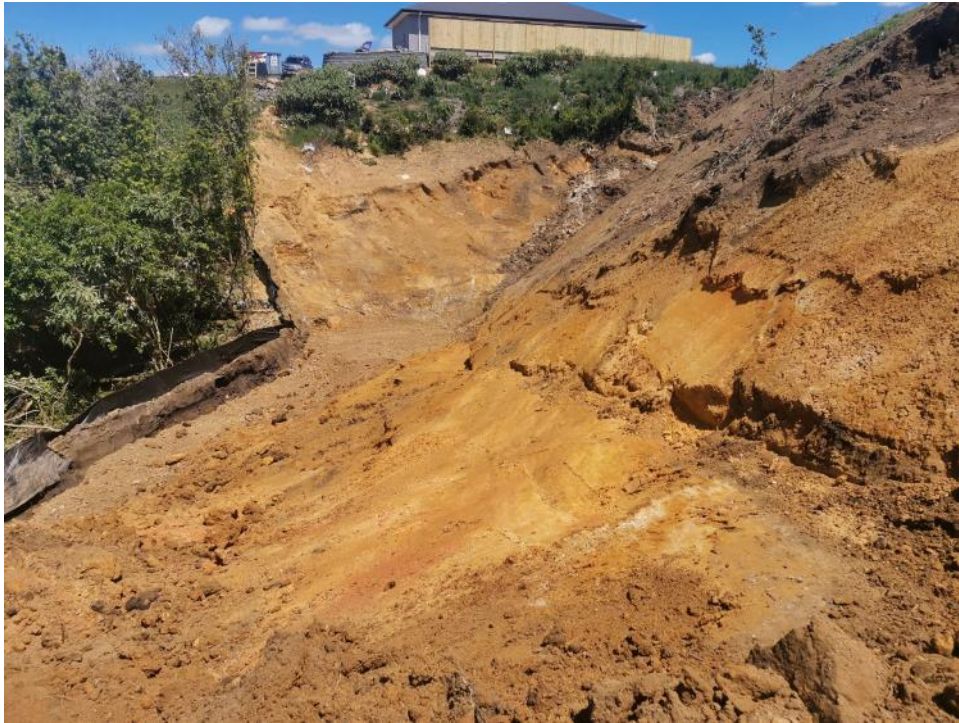
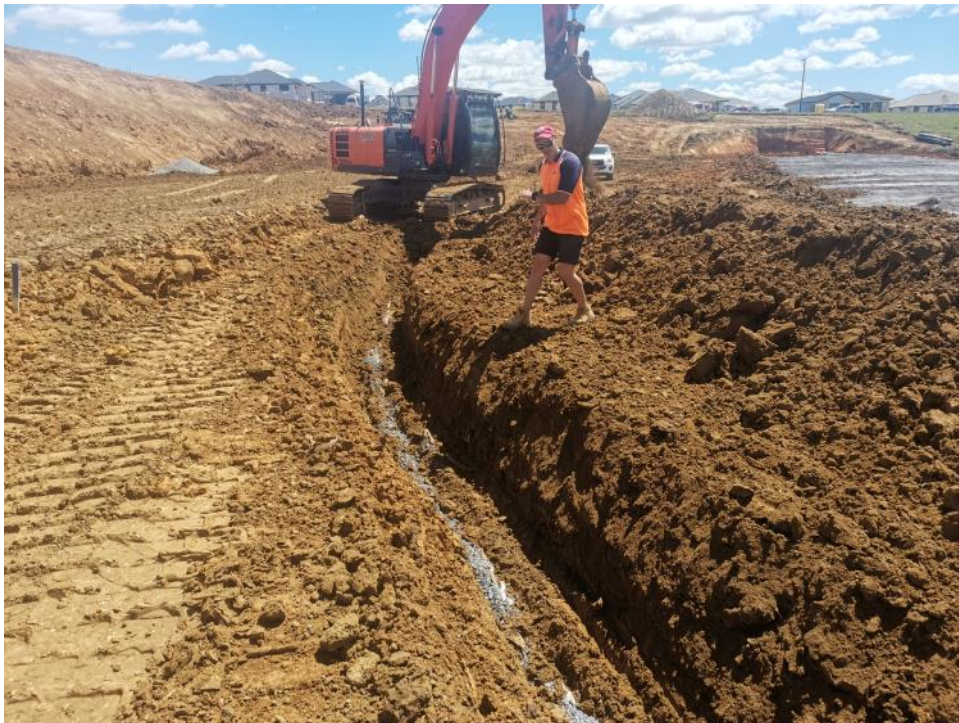
Observed shear key operations in this gully. The shear key looked that same as our previous inspection, and the gully is still being mucked out for the shear key. From what we can see the base appears hard, however, we haven't been able to test the base of the shear key yet due to the muckout still needing to progress.

Not much progress has been made since our last inspection in this area. The SPR in the base of the gully is still loose and requires compaction. The contractor is planning to bring a pad-foot roller down to this area to start backfilling the gully.

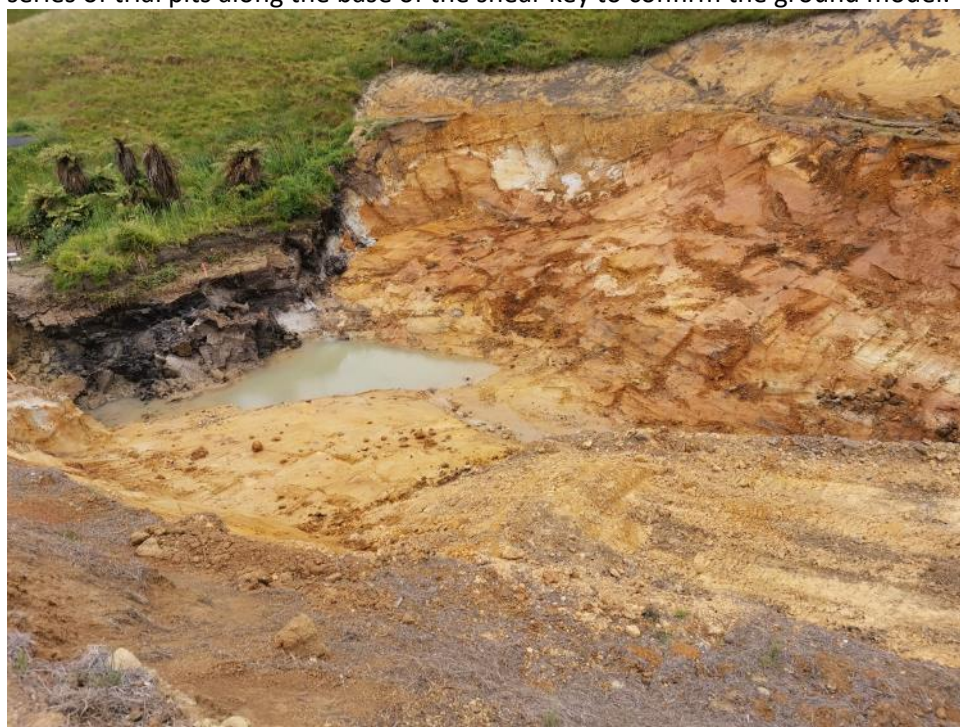
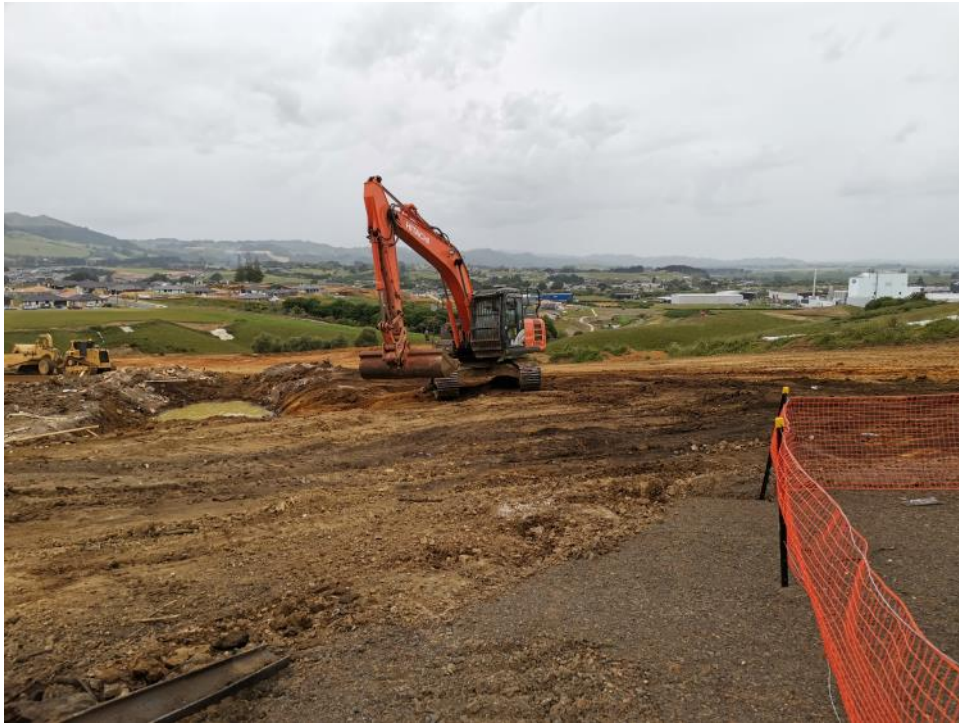
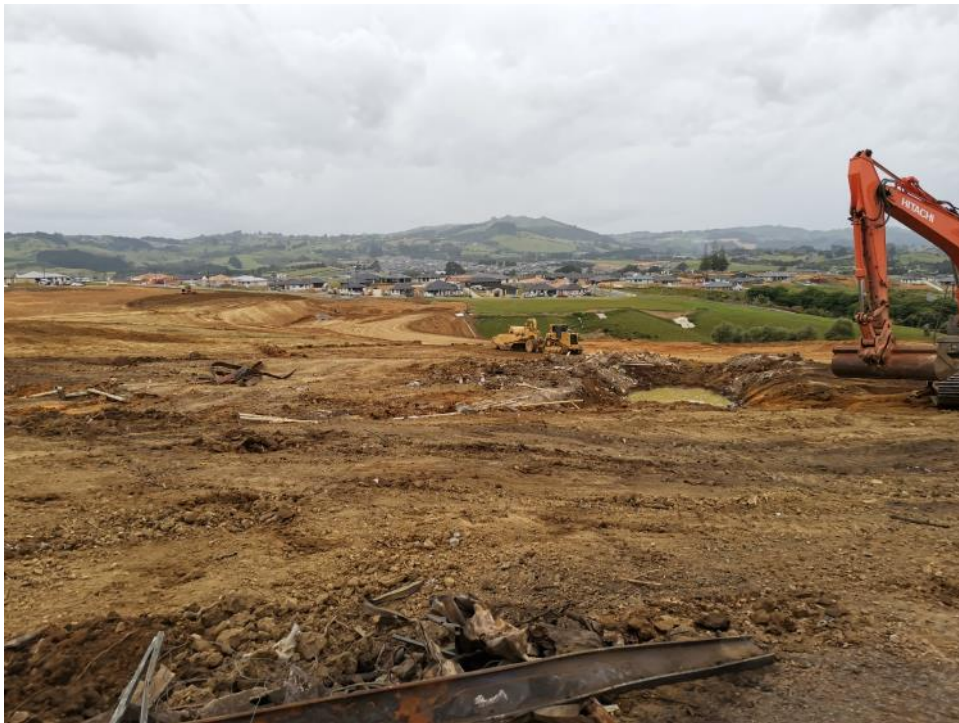
24/11/20 - REB2

Visited site at the request of Dylan to inspect earthworks operations in REB2 shear key.

The shear key has been opened up slightly more since our last inspection, however, more works are still required to enable proper access into the shear key. Once this has been done we will observe a series of trial pits along the base of the shear key to confirm the ground model.

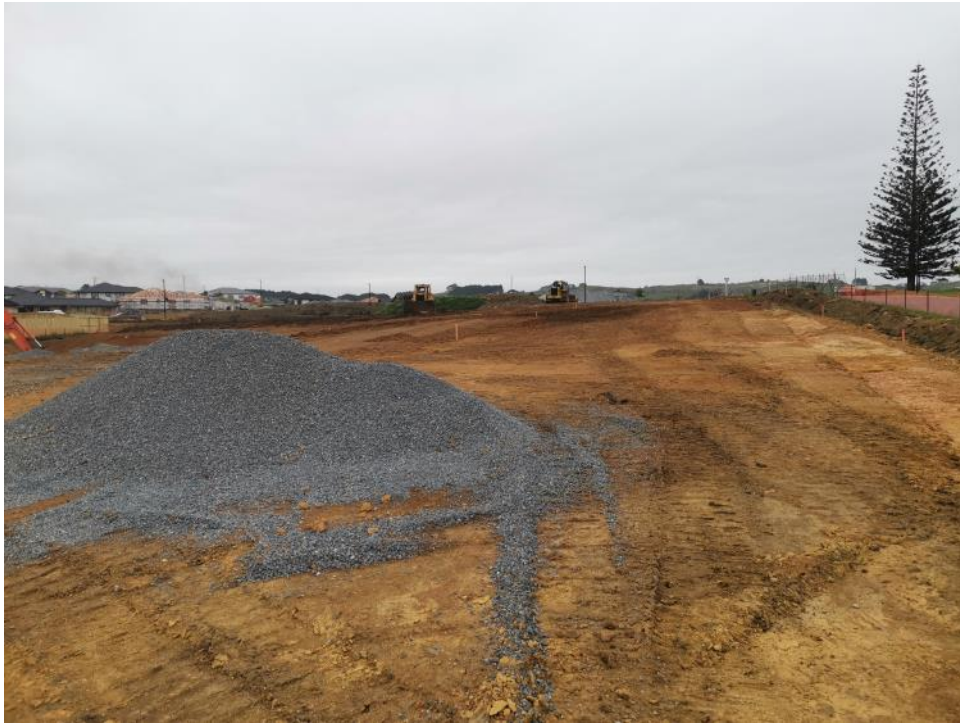
30/11/20 - Stage 12D

Not much progress has been made since our previous inspection and there is spoil along the gully which is still to be cleared. Also discussed that a toe key is required at the base of the proposed fill batter, which the contractors are proposing to install prior to building the fill batter.

Also discussed the stripping in Lots 611 and 612 which Russell emailed about last week. This area is still covered by a topsoil stockpile. Advised the operator to get Dylan to get us in for an inspection prior to placing fill in this area.

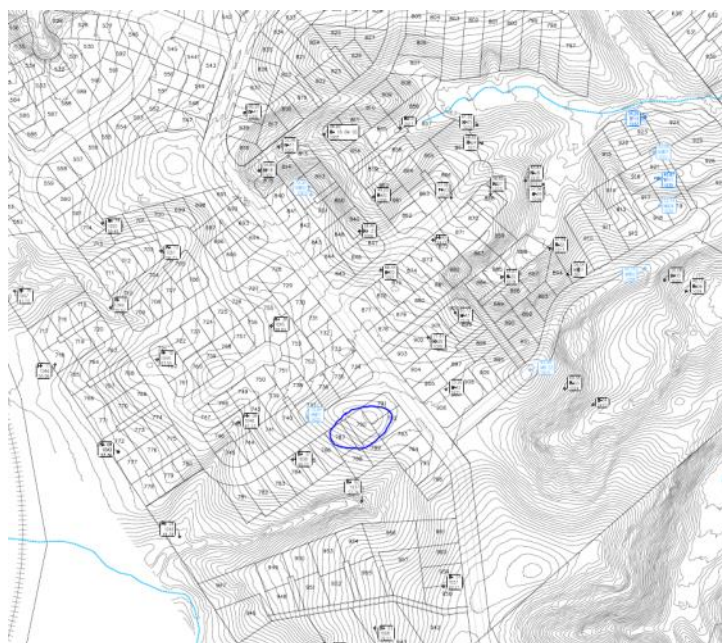
Visited site at the request of Dylan to inspect an area of cut which the contractors are struggling to excavate. Dylan was concerned that the material may cause limitation for future end-users / builders. Dines were querying whether an undercut backfilled with certified clay would be a good solution.

On site, the material comprised of a welded tuff. Advised that I would talk to Chris or Shane before providing any advice.

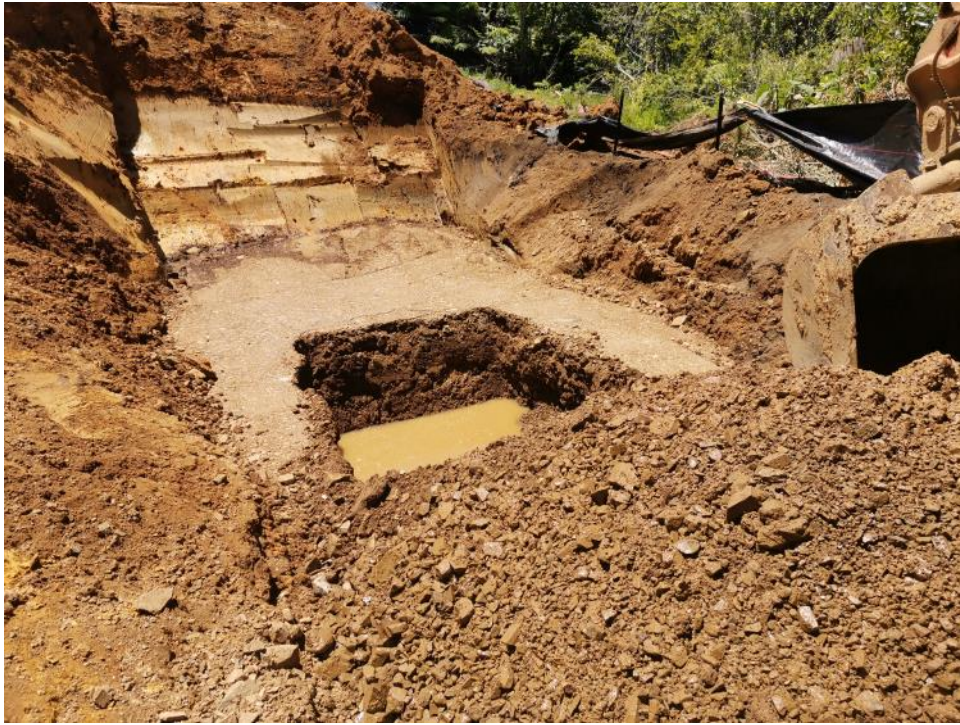
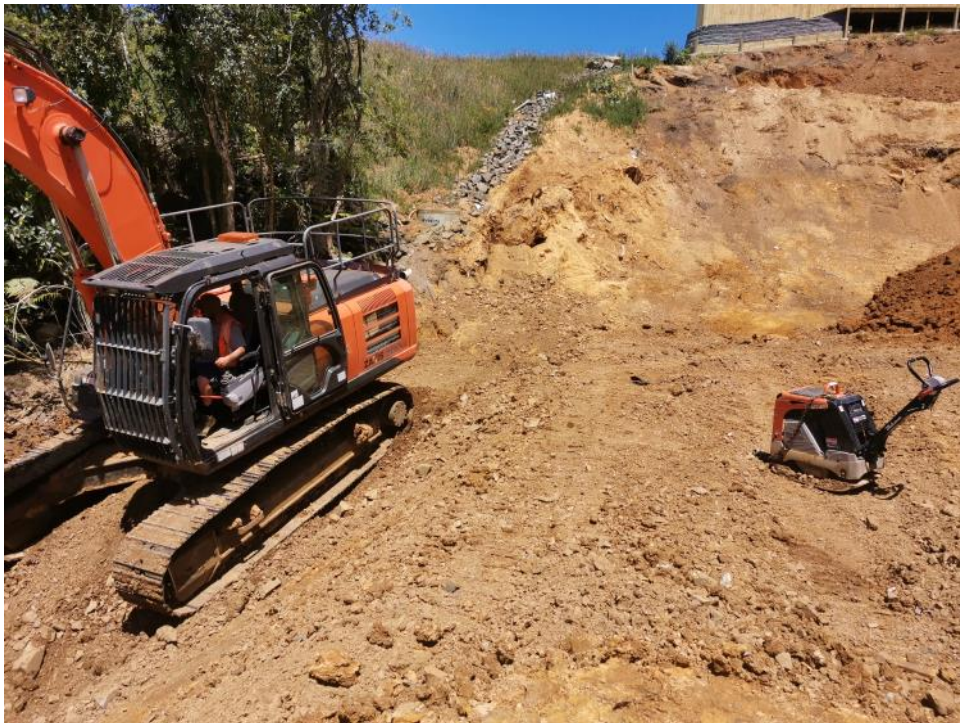
12D fill/toe key area:

Visited site to inspect 12D toe key. Contractor had already filled with SPR to 1.5m without getting us to inspect or getting fill testing so asked them to dig back to subgrade in the centre. Firm soils exposed at the base, however, the toe key will be about 2-3m thick so no undercut was recommended. Contractors said they needed to backfill the area immediately. We advised that they need to give adequate notice for geotech and fill test inspection in this case.

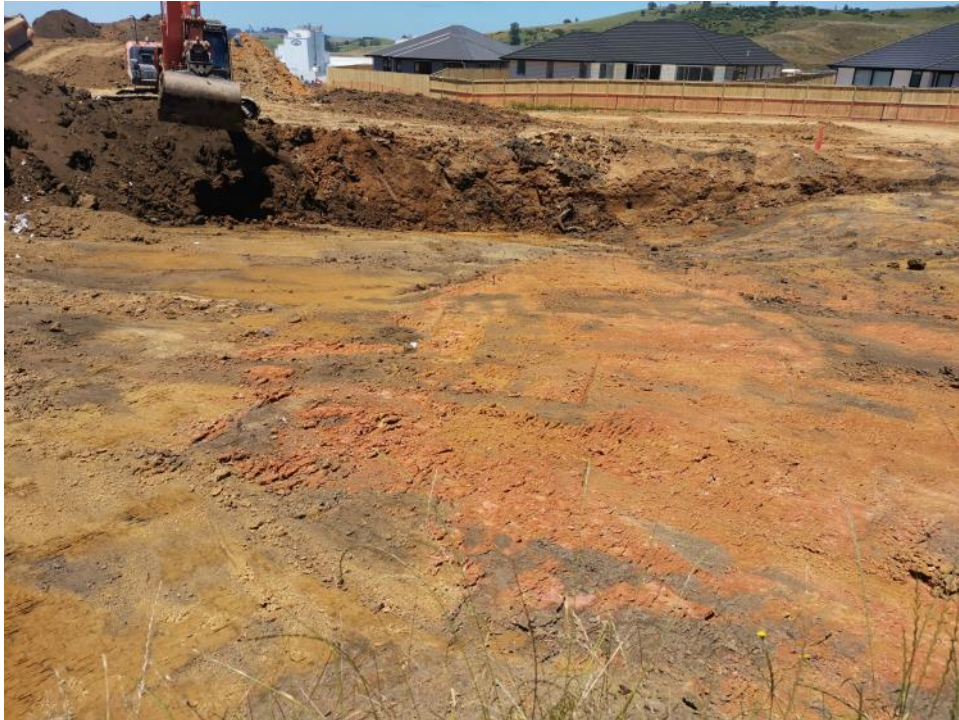
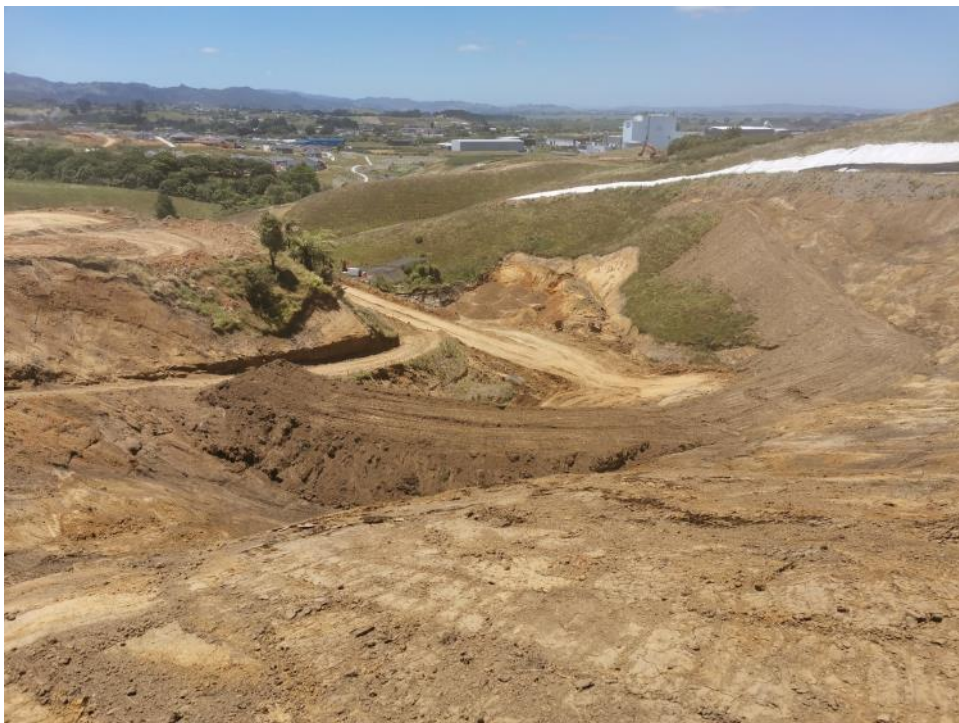
- Stage 12D toe key. The contractors failed their previous test here, achieved CIV readings of around 10. They removed the material, discarded the wetter SPR and refilled with a heavier roller. Josh to retest. The model also needs to be rechecked to confirm minimum toe key requirements are adequate.

- Also observed the stripping area in lots 611 and 612. Rubbish/pre-existing fills are still present. Reiterated that these materials be fully undercut. Will return to site tomorrow to observe general earthworks operations.

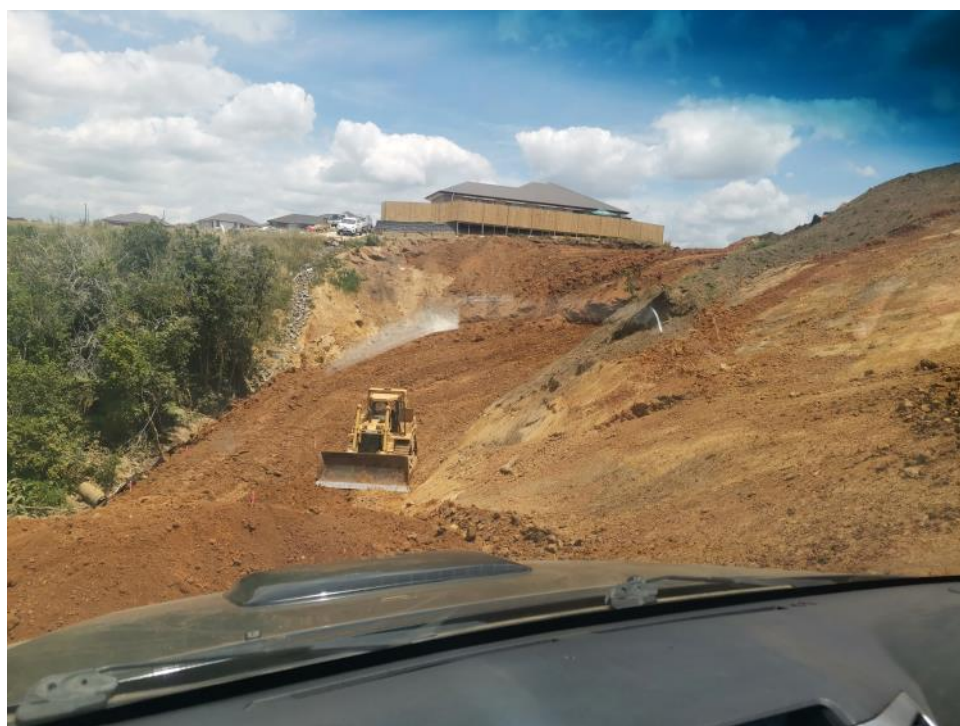
Visited site at request of Dylan to observe site works prior to the Christmas break. Not much has progressed since our previous visit. Toe key has been completed and clay fill for the 1(v) in 3(h) batter is now commencing.

Also requested that some more fill be placed to buttress the site cut at the top of the gully flank to ensure stability is maintained to the house.

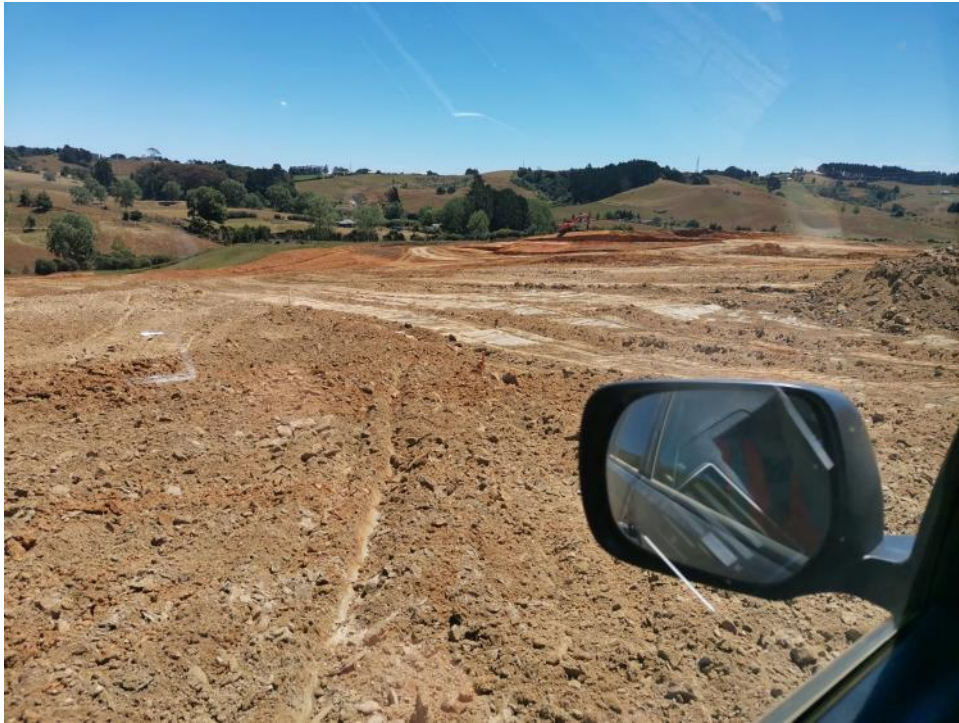
Welded tuff area
