Geotechnical Completion Report

HITCHEN BLOCK STAGE 13A

DFH JOINT VENTURE LIMITED

16 August 2021

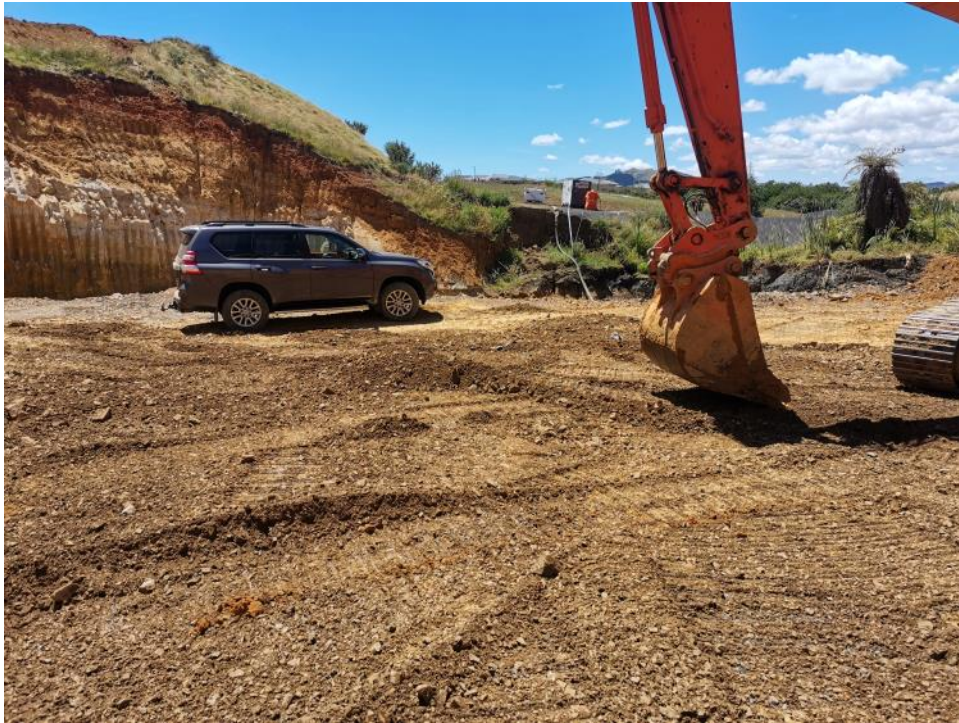
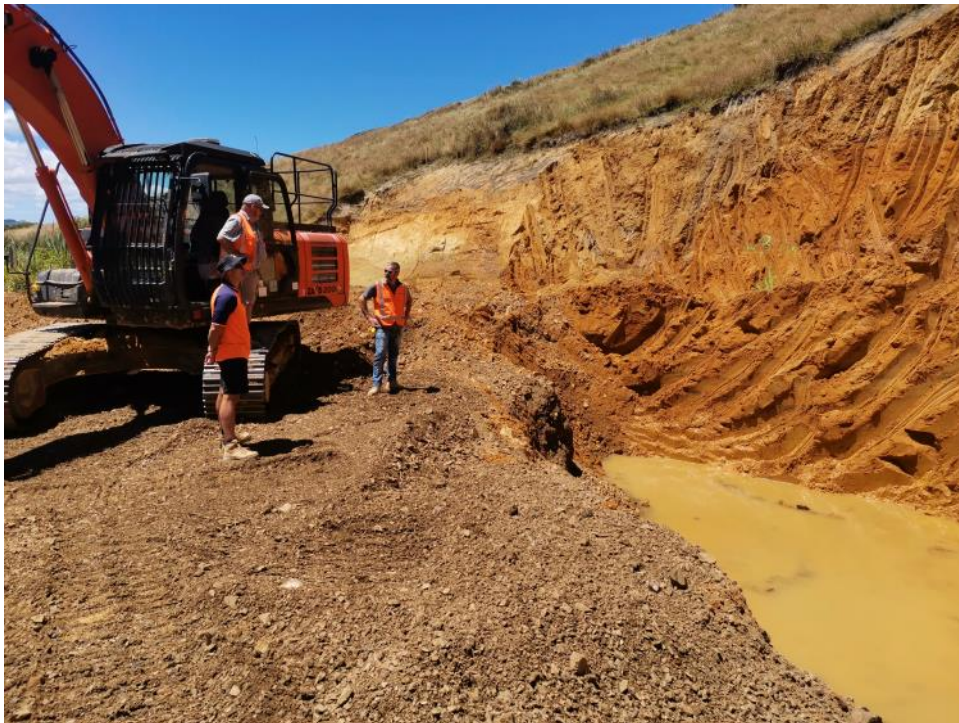
REB2 shear key

Also inspected REB 2 shear key progress. Backfill of the shear key in progress. Fill testing was being carried out at the time of our inspection of the area beyond the key where the groundwater was being pumped from.

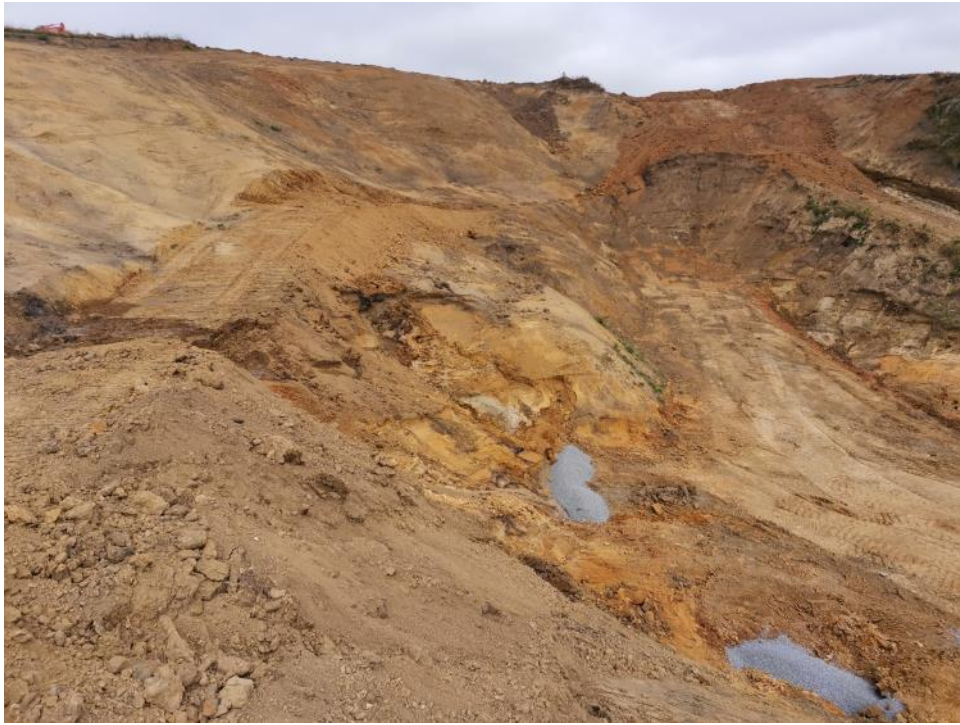
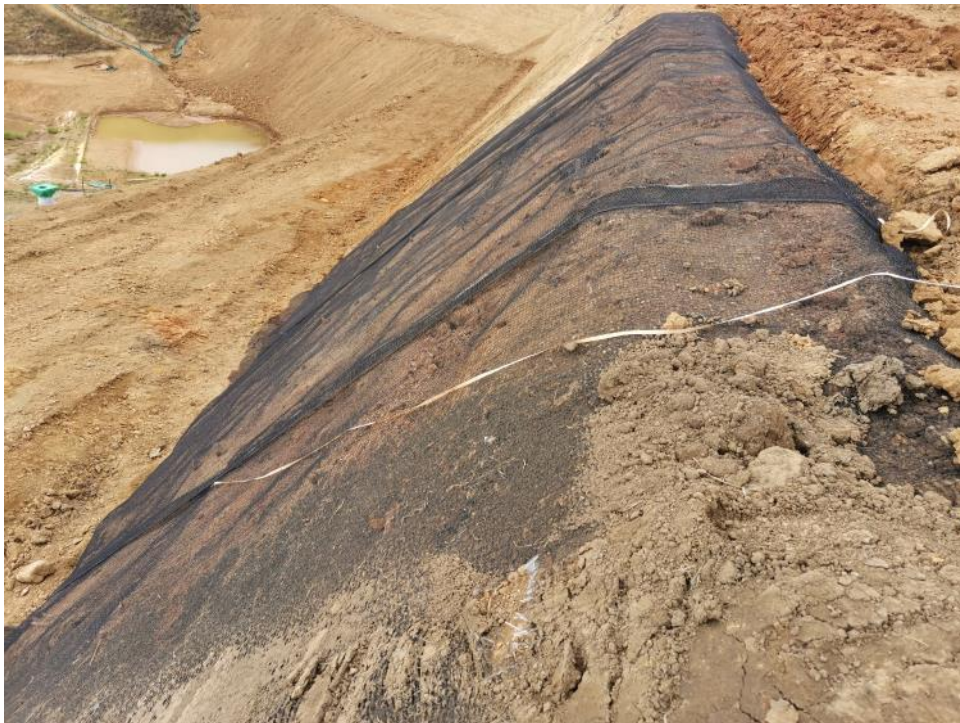
29/01/21 - REB1&2

At REB 2, construction of the shear key is almost complete and several underfill drains have been installed as per our recommendations.

Also inspected final works for lots 611 and 612, adjacent to stage 12D. Both lots have been topsoiled, with 100mm of topsoil measured in both lots.

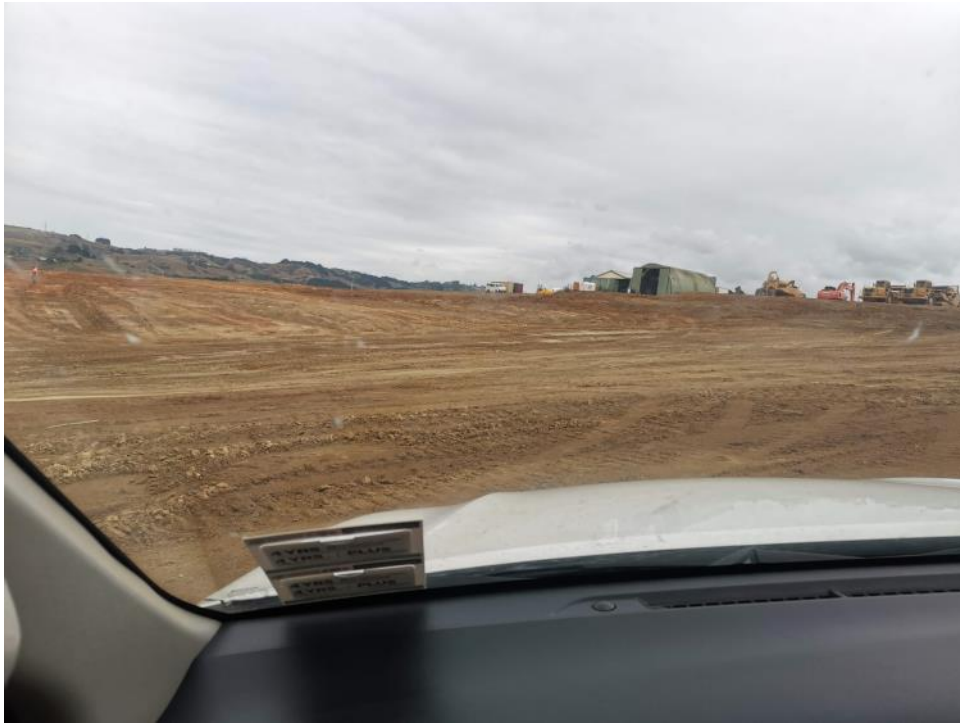
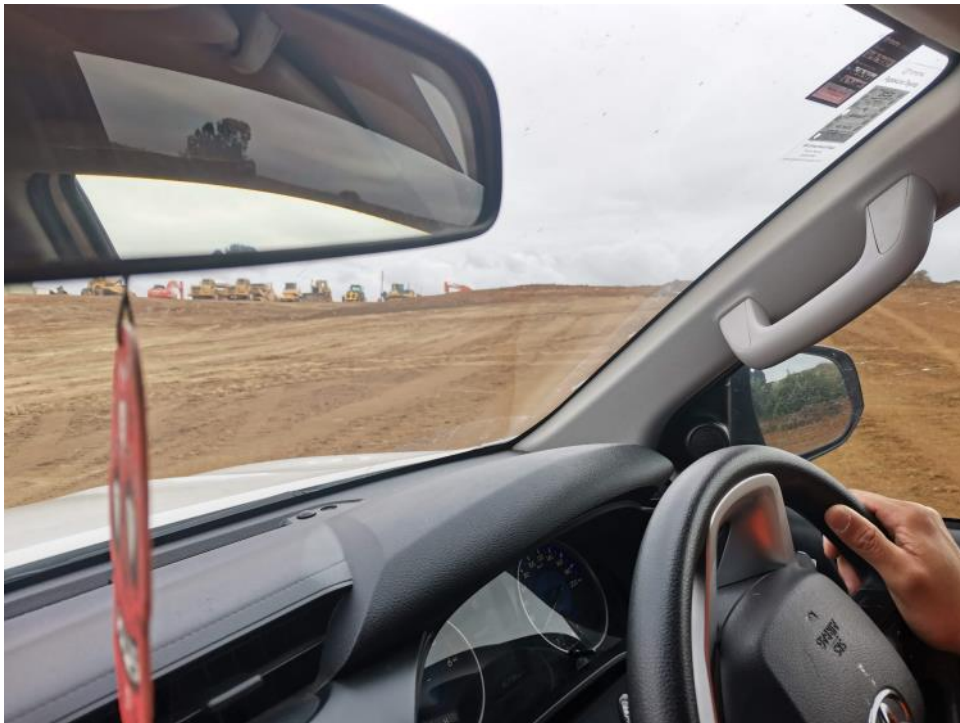
11/02/21 - REB1&2,welded tuff area

- Within REB2, the 1m GAP65 layer is now complete and clay filling is about to commence. The rear blanked drain is being installed, however, the main underfill drain has been severed and the contractors were advised to repair this prior to backfilling.

- At the REB1 wall face, the contractors are still having difficulty placing topsoil along the facing. Advised the contractor to keep talking to Cirtex and their hydroseeders for advice as necessary.

- The old slip above the REB1 silt pond is about to be backfilled. Advised contractors to trench in an underfill drain prior to benching into the slope and filling. The underfill drain will outlet at the same point at the REB underfill drains, but with a different outlet point.

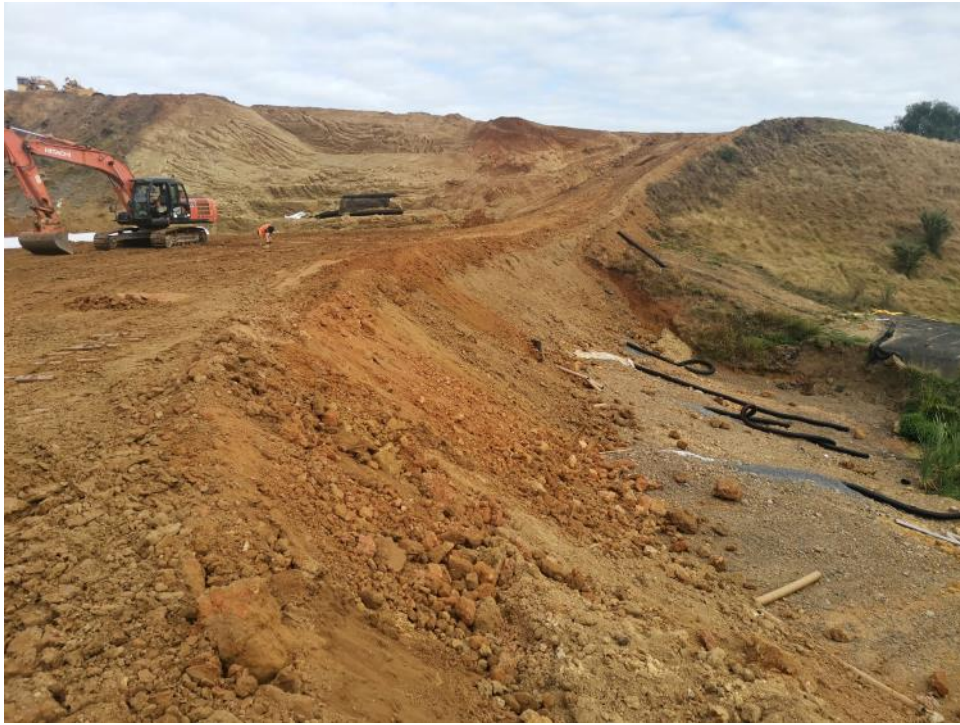
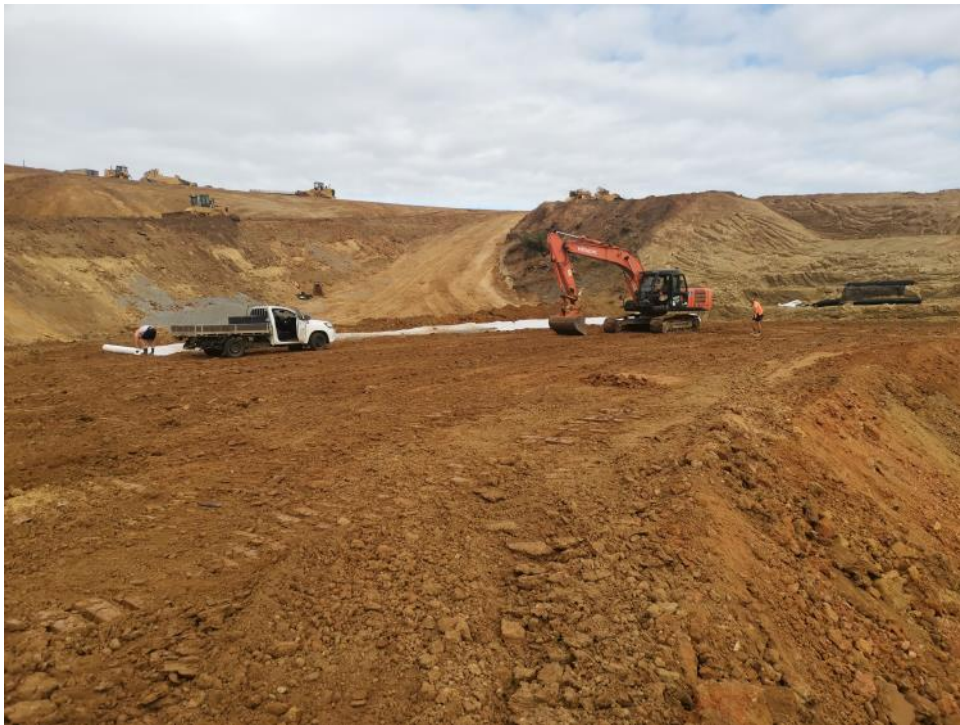
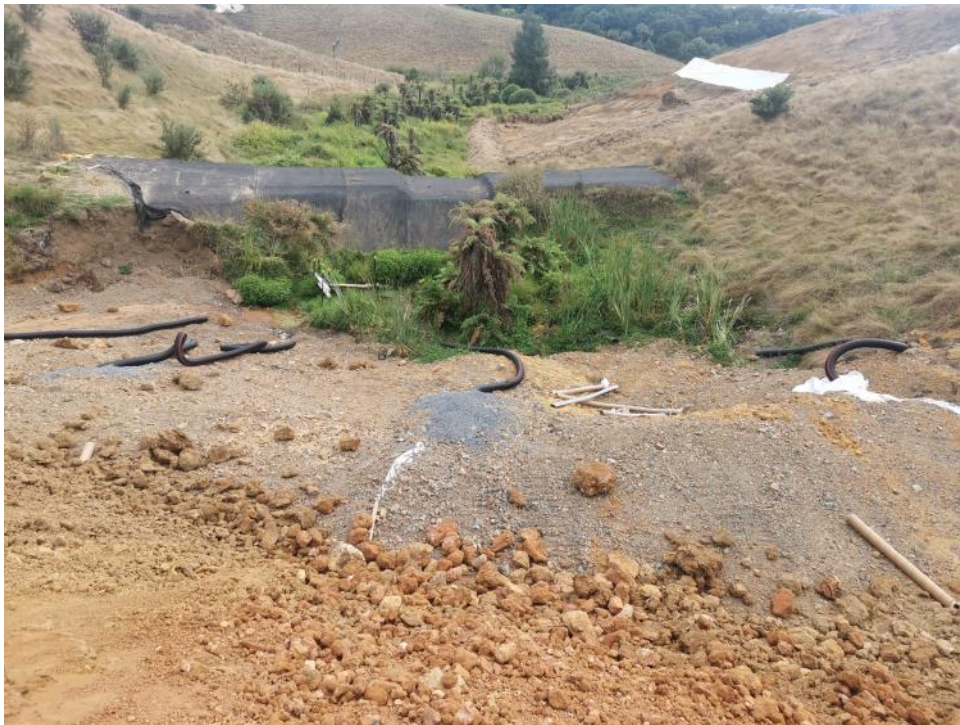
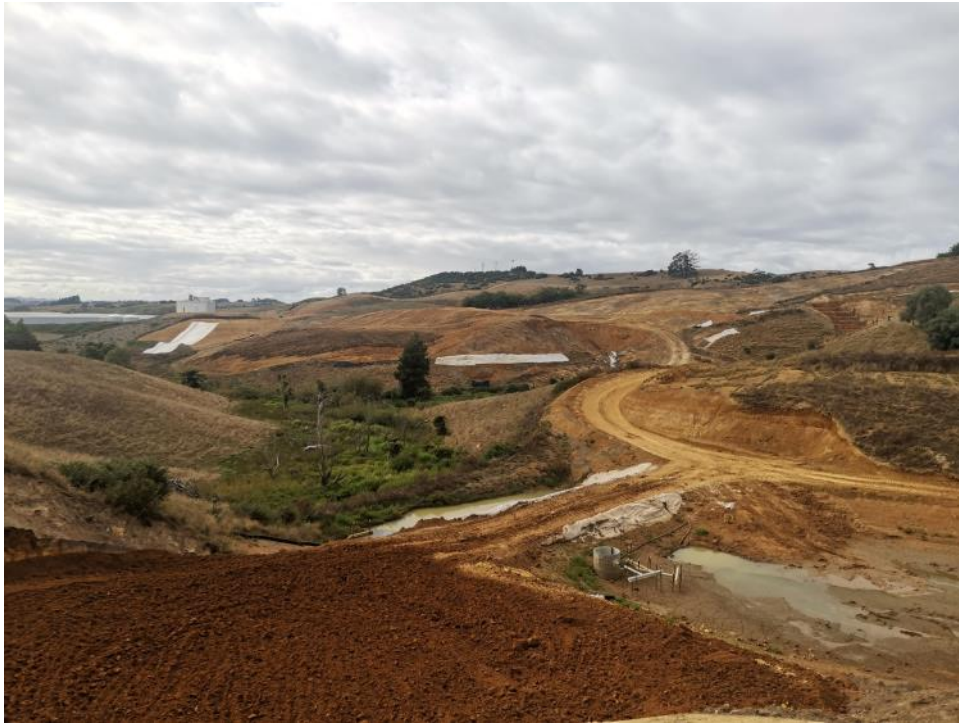
24/02/21 - REB1&2

- Fills are progressing in REB2. All 4x underfill drains can still be observed at the toe of the batter.
- Slip remediation works progressing below DEB10 (adjacent to REB1 silt pond). Underfill drain observed below current fill batter as per our recommendations.

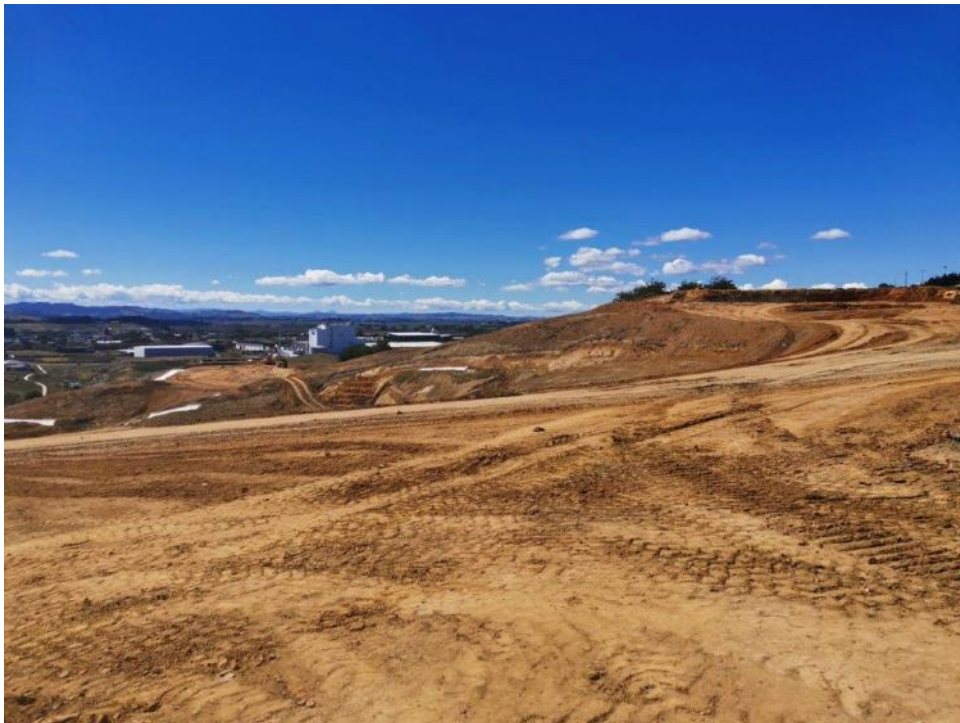
12/03/21 - REB1, REB2

- Filling is now complete in the old slip adjacent to the stormwater pond below REB1. The area is now being trimmed and topsoiling is planned soon.
- Inspected filling operations in REB2. The REB is now in the middle grid area and 10m lengths of SG500 grid were recorded throughout.
- Cut progressing above REB2.

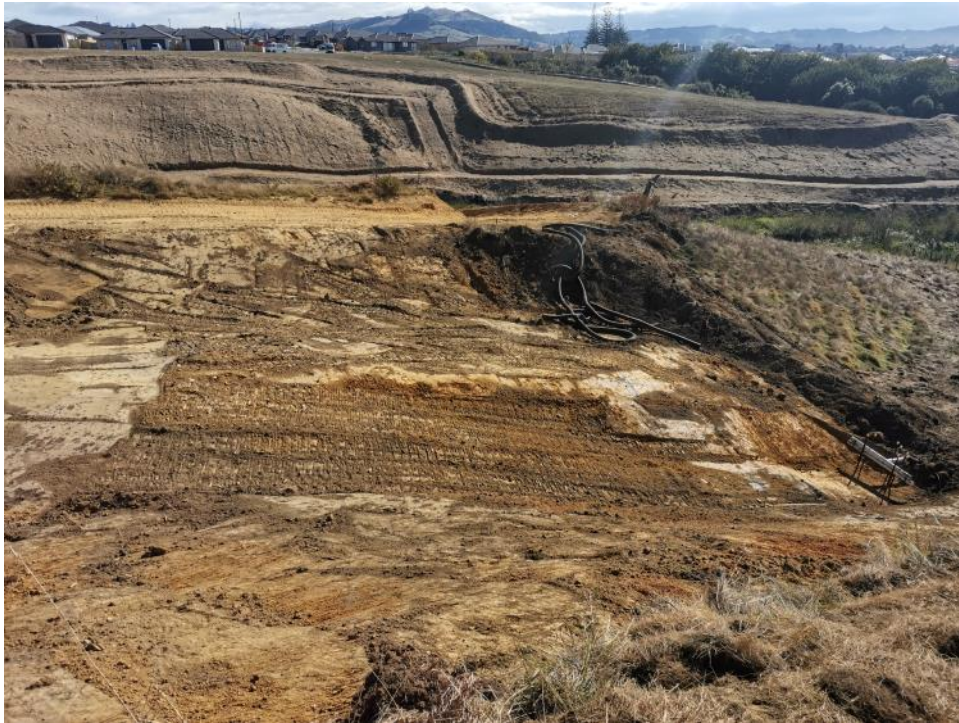
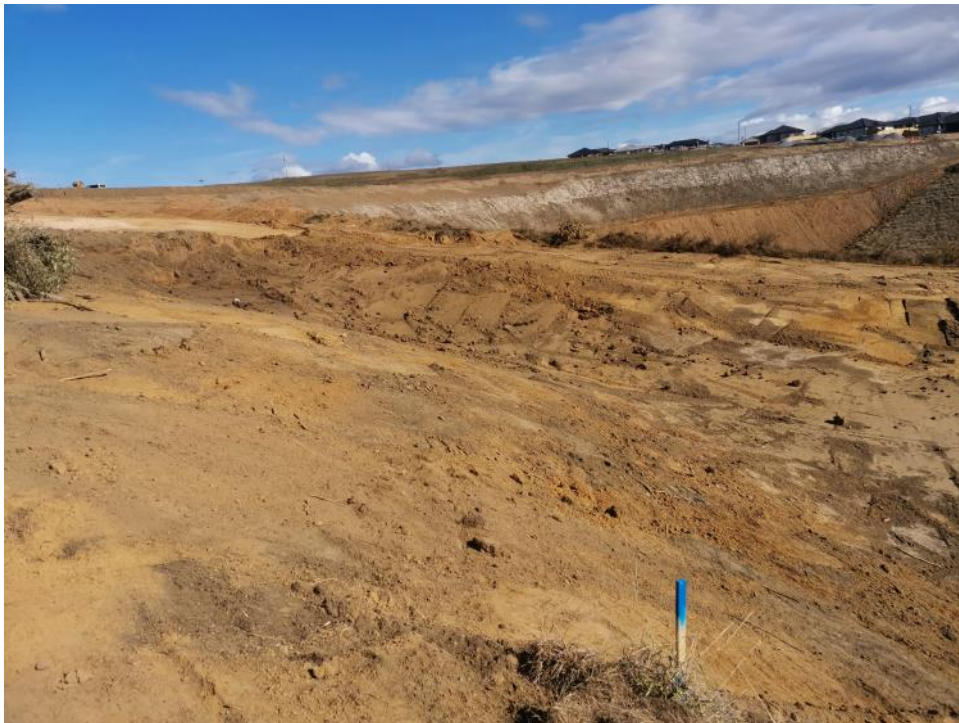
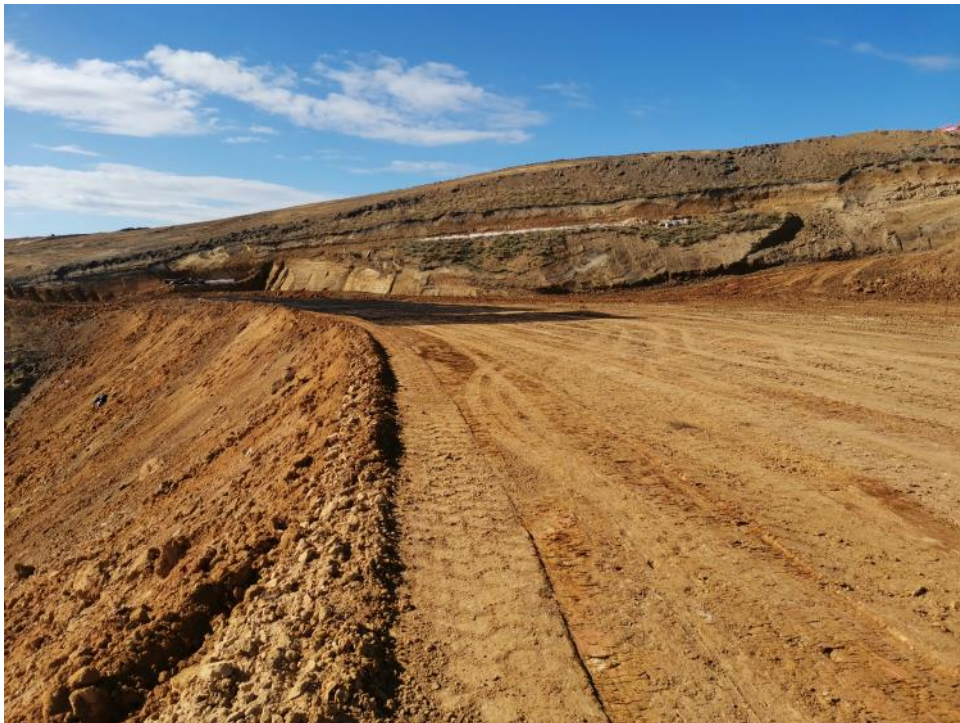
07/04/21 - REB1, REB2

- REB 1 face is currently being trimmed. The contractors are working along a bench at approx. mid slope height and trimming back to design level. No grid was observed on the face of the excavation. Requested that up to date as-builts be supplied to us to ensure that design requirements are being met
- REB 2 has been filled to near full height and a layer of secondary grid was exposed at the time of inspection.

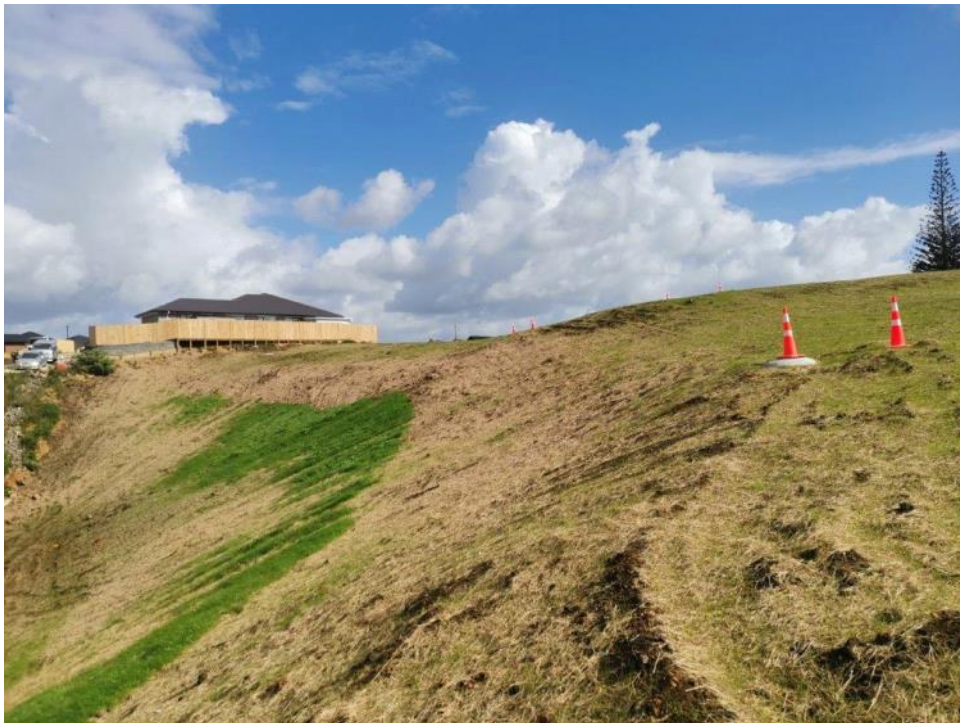
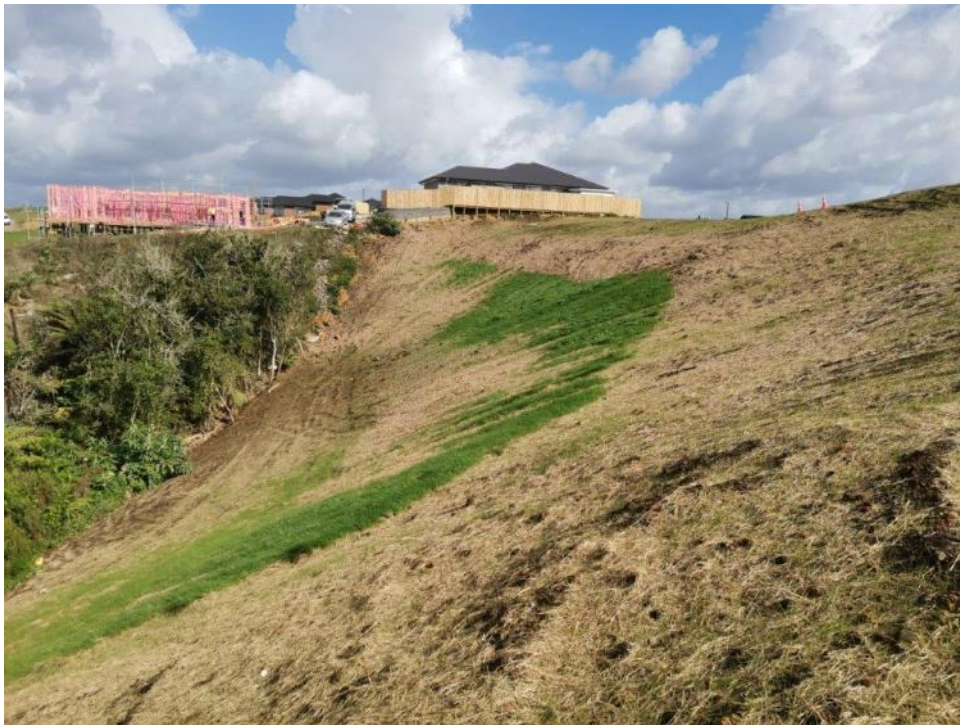
16/04/21 - Stage 12D

Telecom with Trevor, discussed that underfill drain was not visible. He is going to install a solid pipe to avoid blockage of the drain through the topsoil at the toe of the 1(v) in 3(h) batter, and then form the permanent outlet structure at the end of the solid pipe. Advised to return on Monday to sight this.

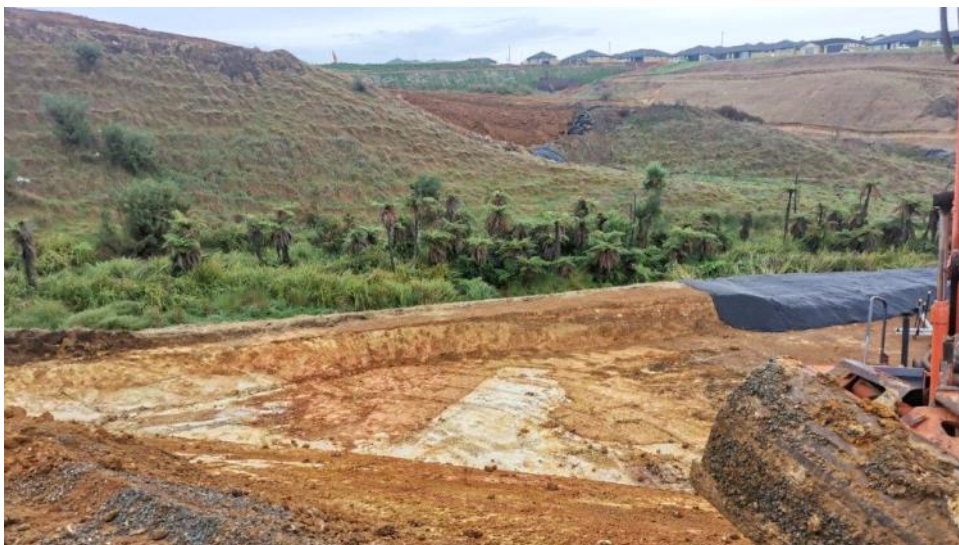
20/04/21 - Stage 12D, REB2, Fill M

- Sighted underfill and permanent outlet structure in Stage 12D.
- Filling progressing in REB2, with fill placement near final subgrade level. Several more layers of fill to be placed near the crest to meet design heights.
- Underfill drain in Fill M is to outlet into the permanent stormwater pond. Advised that this should be protected with a rock channel or similar to prevent scour along the side of the pond.

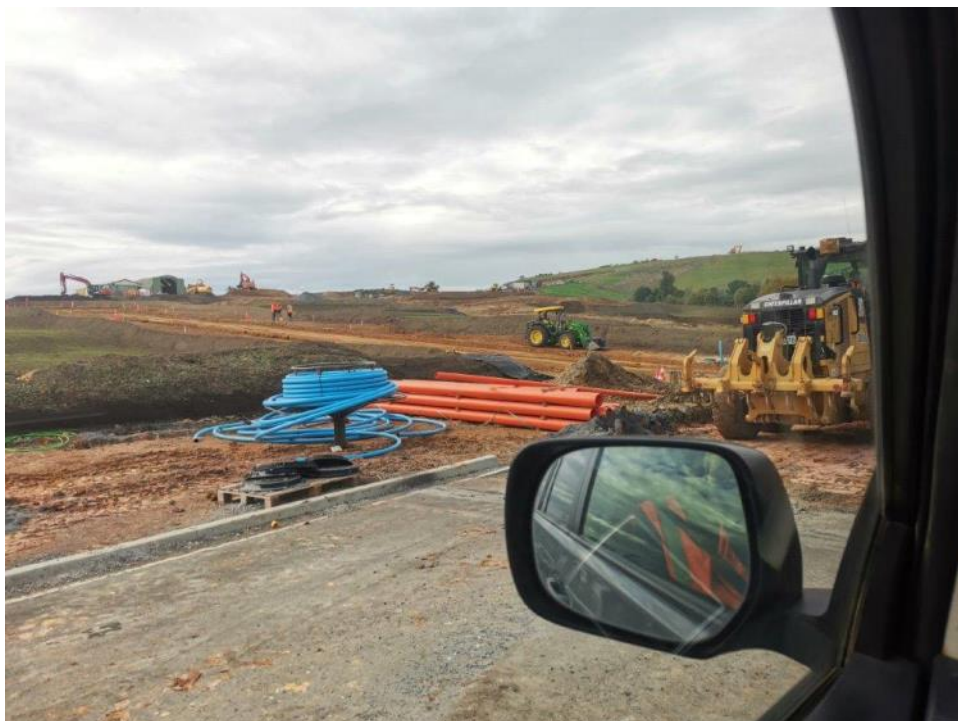
- Stage 13 nearly complete. Observed permanent underfill drain outlet beneath the permanent stormwater pond.
